# Southern Star Inspections, LLC

## Property Inspection Report

1234 Texas St, Houston, TX 77040

Date of Inspection: 4/27/2020 Time: 8:30 AM

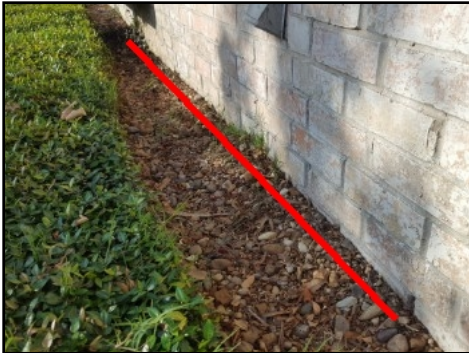
• Foundation could not be inspected at various locations due to high soils, overgrown vegetation, sidewalks, attached and/or decks/patios. Recommend trimming all trees, bushes, and lowering grading/mulch beds away from the foundation walls so the foundation walls can be monitored.

Foundation covered at various locations

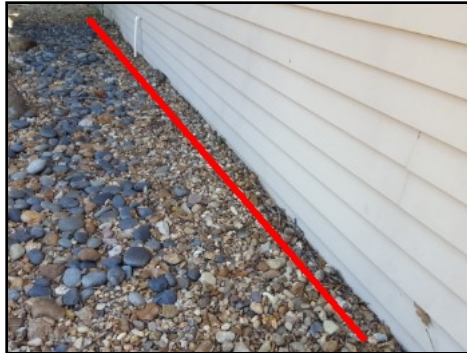
Foundation covered at various locations

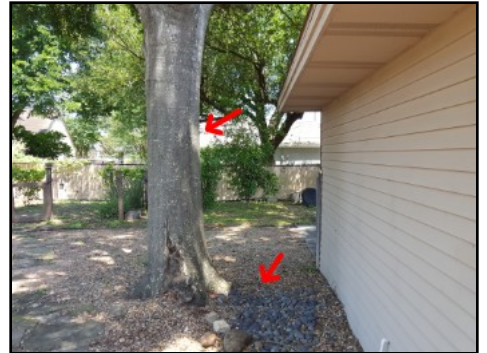
• Trees/tree roots are located near or against the foundation wall at the left and rear elevation of the home. Inspector did not observe any damage to the foundation or exterior cladding at the time of the inspection.

Tree/roots near foundation at rear elevation

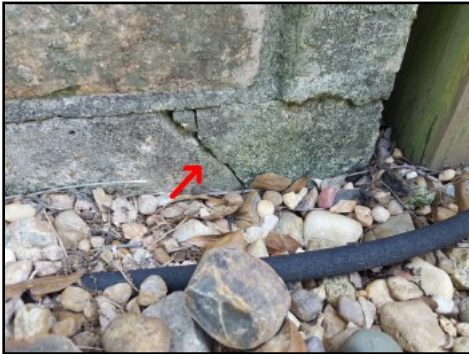
• Truncated cracks were observed at the corners of the foundation. These are known as "wedge" cracks that are not negatively affecting the structure at the time of the inspection. Recommend repairing with a non-shrinking epoxy grout/mortar and monitor for excessive movement.

Wedge crack at rear left corner

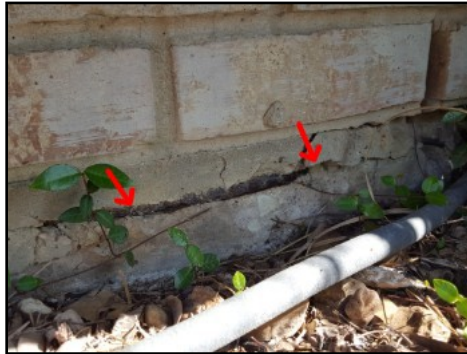
• Foundation rebar is not properly sealed at the front right elevation of the foundation wall at the time of the inspection. It is recommended to seal/patch these with a non shrinking epoxy grout to prevent corrosion of material. Check all.

Exposed rebar at front right corner

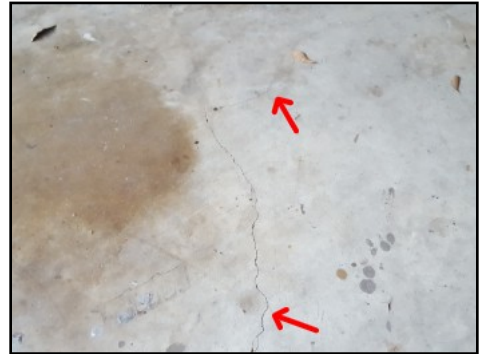
• Shrinkage cracks are present in the garage foundation. Minor settlement or "hairline" cracks in drives, walks or even foundations are normal to properties of any age. The cracks/fractures were tight and free of differential movement (no vertical displacement). These are primarily cosmetic and can be sealed to prevent water intrusion. Recommend monitoring for excessive movement.

Hairline cracks in garage

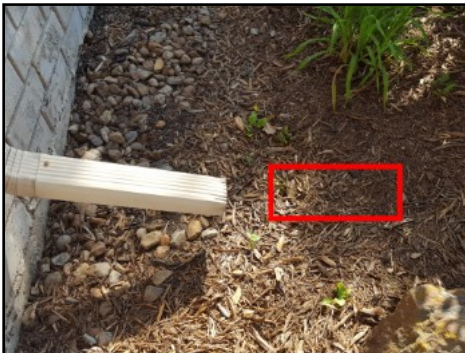
Missing splash block

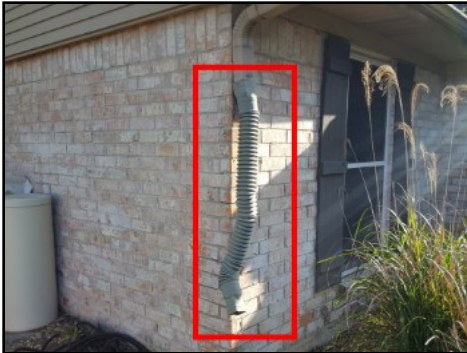
- **Gutter downspouts are missing at various locations of the home at the time of the inspection. Check all.**
- **Gutters are not installed behind/beneath the metal drip edge at various locations of the home at the time of the inspection. This can allow the water to run between/collect between gutter and the fascia material. Check all.**

Gutter downspout not present at front elevation

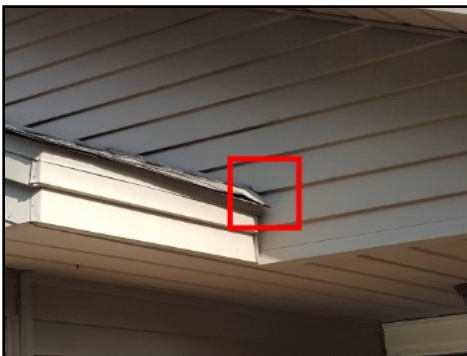
Missing kick out flashing

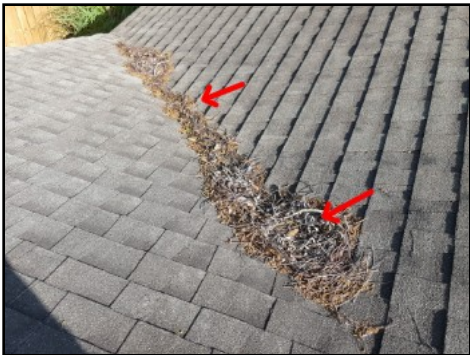
- **Observed vegetation debris such as leaves and/or pine needles on the roof covering that should be removed as needed. Check all.**
- **Breezeway roof covering has buckled/cupped asphalt shingles present at the time of the inspection. Installation of asphalt shingles on a roof slope less than 2:12 pitch is not permitted. Asphalt shingles shall be used only on roof slopes of two units vertical in 12 units horizontal (2:12) or greater.**

Debris on roof covering

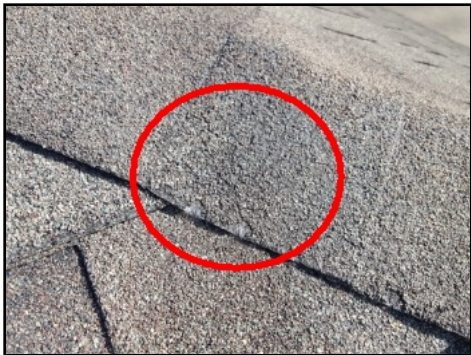
- **Asphalt shingles are brittle and show wear at various locations of the roof covering at the time of the inspection. Recommend consulting with a licensed roofing company to determine maintenance costs, life expectancy and/or cost of replacement when/if needed.**

Worn shingles present at various locations

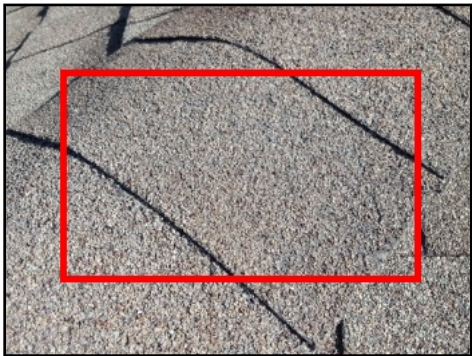
Worn shingles present at various locations

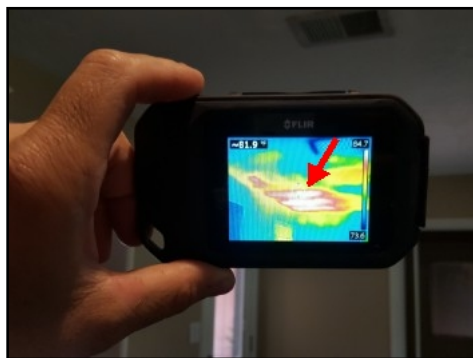
- Inspector observed higher than normal temperature differences/transfer at various locations of the interior walls and ceilings using thermal imaging camera. Some of these areas are common due to the roof/wall configuration. Insulation may be missing or not properly installed which allows unconditioned air to pass through the drywall and into the home. Installing insulation so that all areas have an equal R-value has proven to save energy.

Evidence of heat transfer at morning area

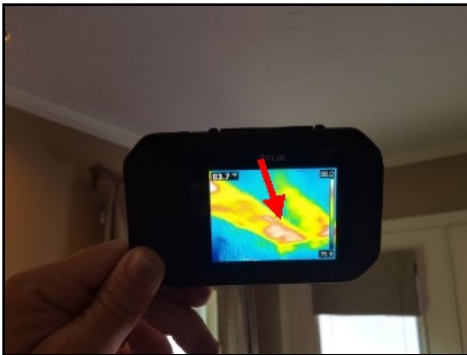
Evidence of heat transfer at master bedroom

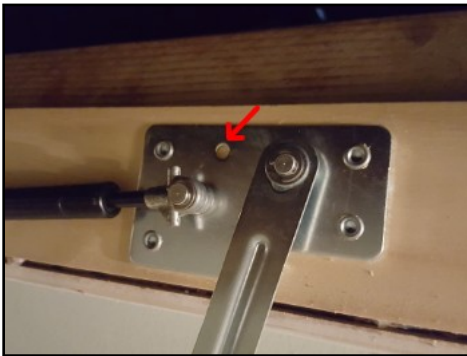
Attic staircase missing securing hardware

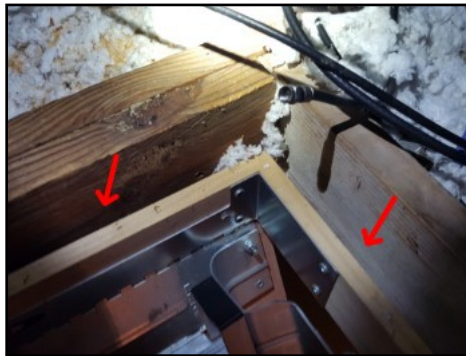
Attic door jamb not foam sealed

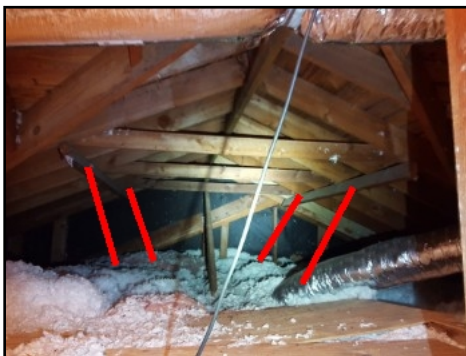
- Missing purlin bracing within the attic space at the time of the inspection. Purlin bracing should be no less than 2x4 material placed no more than 4 feet apart to help support the weight of the rafters/roof covering. Check all.

Missing purlin bracing

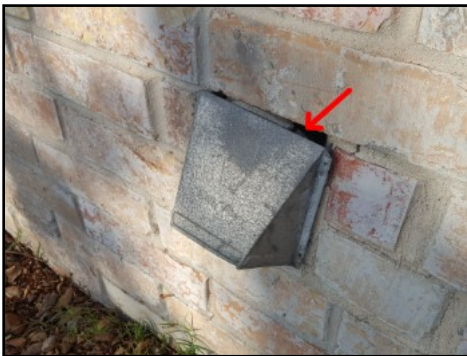
Seal all exterior penetrations

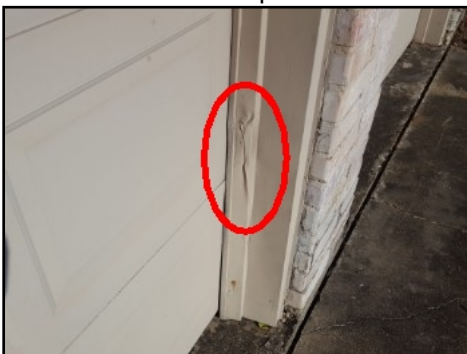
Damaged siding trim at garage

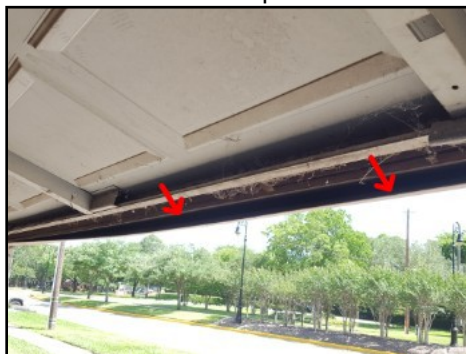
- Vinyl siding material is not properly secure in place at the garage door and at the right elevation window bay. Building material is exposed and deteriorated at the right elevation window bay at the time of the inspection. Recommend securing and sealing all gaps/voids in vinyl siding material. All exposed nail heads securing siding material to structure should be sealed as needed. Check all.

Siding not secure over garage door

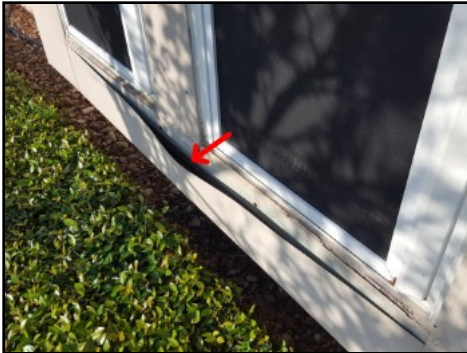
Siding not secure at right elevation window

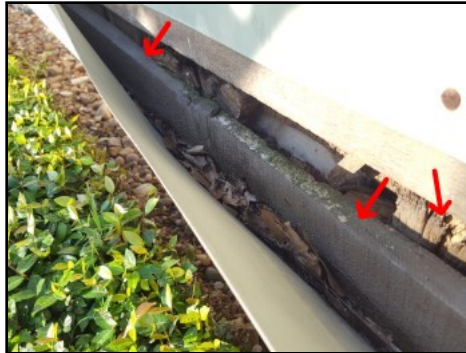
Deteriorated building material at right elevation window

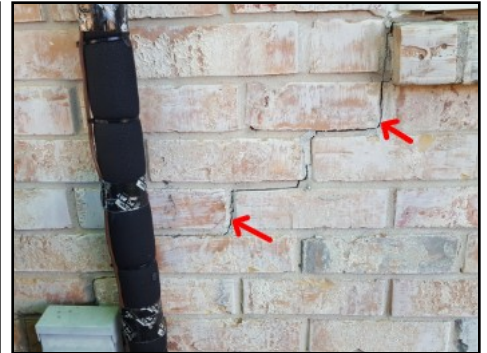
- Settling cracks in brick veneer at various locations of the home at the time of the inspection. Recommend sealing all settling cracks in exterior walls and monitoring for further movement and/or cracking. Check all.

Crack in brick veneer at left elevation

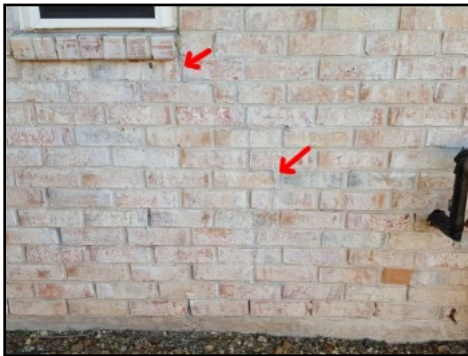
Crack in brick veneer at left elevation

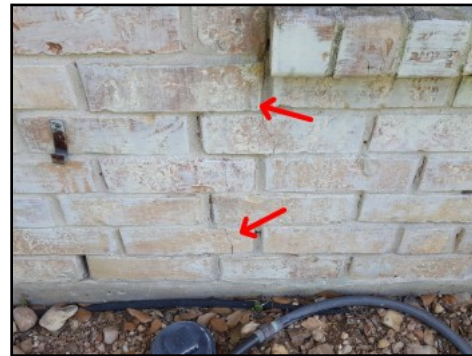
Crack in brick veneer at rear elevation

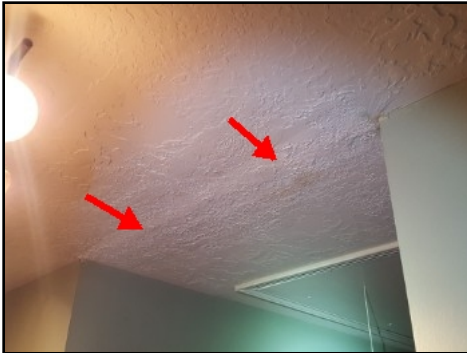
Previous repairs/patches at various locations

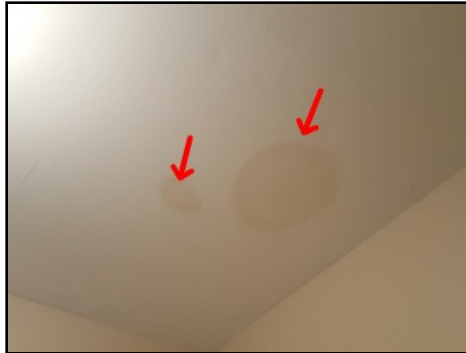
Moisture stain at bedroom closet ceiling

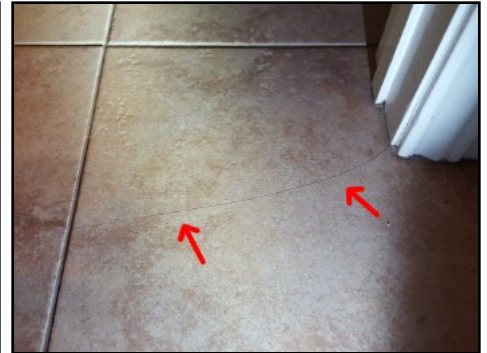
Floor tile cracked at hallway bathroom

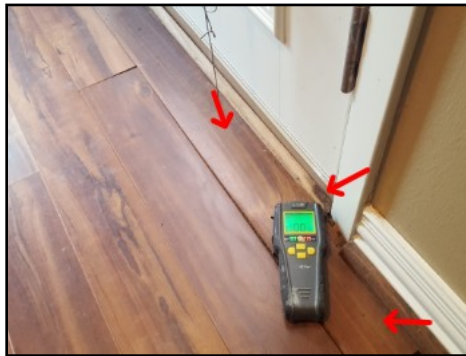
Moisture stains/damage at master bedroom floor

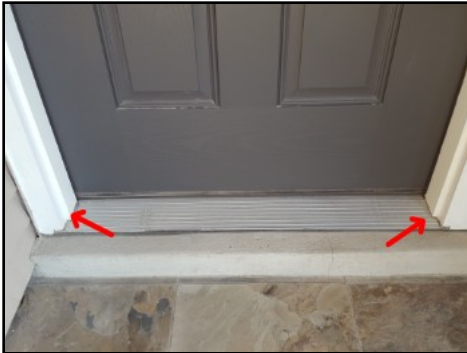
Seal door thresholds/jamb

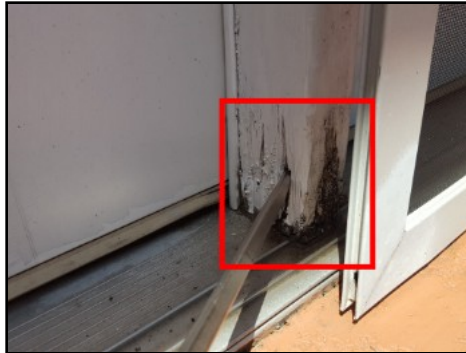
Deteriorated door jamb/trim material

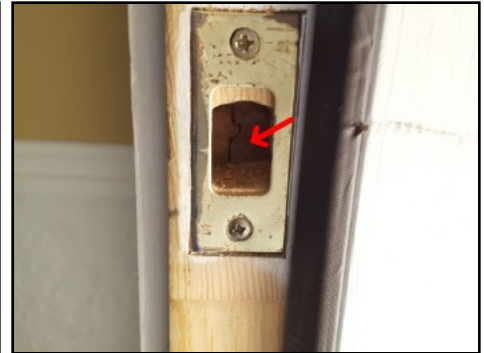
Bore deadbolt hole

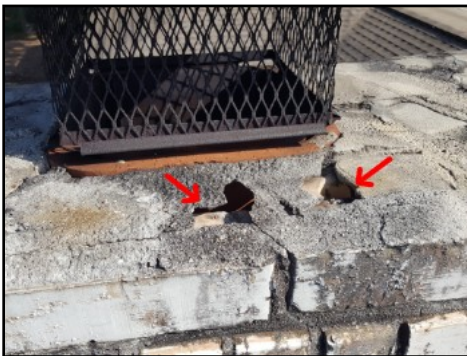
Cracks/voids at chimney cap mortar

- Recommend a full evaluation and repairs made by qualified fireplace/chimney contractor. It is always recommended having a professional chimney sweep and/or licensed contractor conduct a full evaluation of the fireplace and chimney prior to each seasonal use.

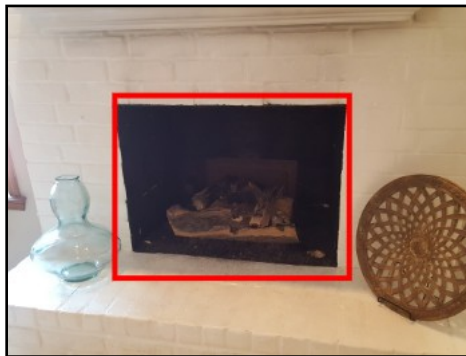
Screen/cover not present

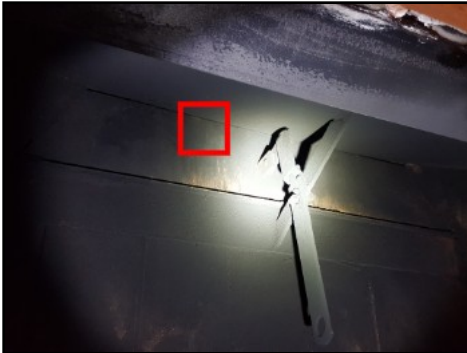
Damper missing blocking clamp

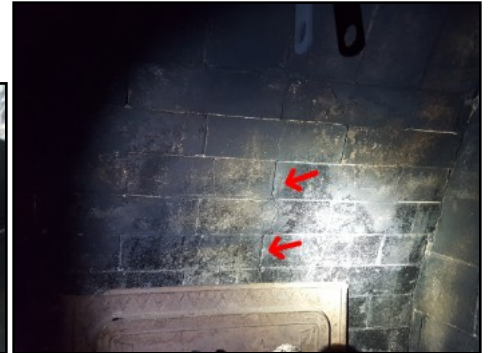
Cracks/voids at fireplace brick mortar

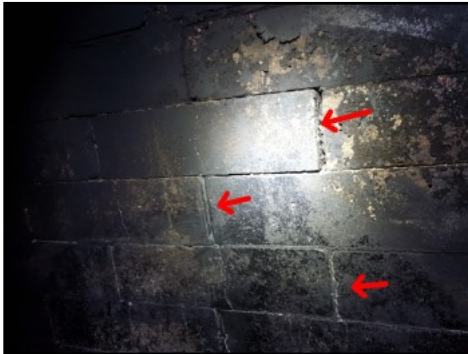
Cracks/voids at fireplace brick mortar

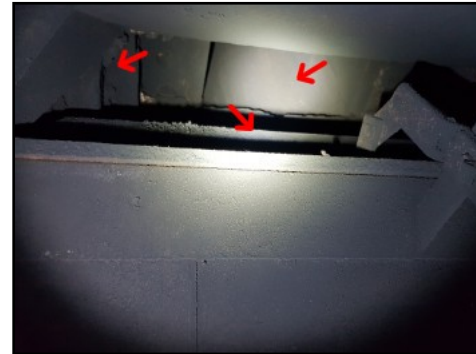
- The fireplace and chimney area has a significant build up of creosote present at the time of the inspection. Excessive creosote build up is considered a fire hazard and should be cleaned/removed as needed.

Creosote build up present within fireplace/chimney

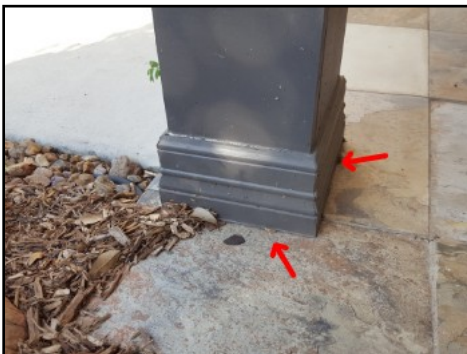
- **Front porch and rear patio column material is in direct contact with the foundation. A 1" gap is recommended so material does not wick moisture and deteriorate over time. Inspector was unable to verify if a post base is present at the time of the inspection.**

Column material in contact with foundation

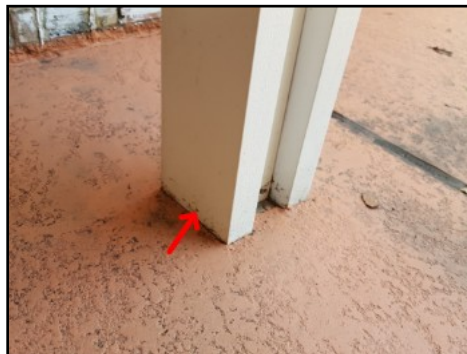
Column material in contact with foundation

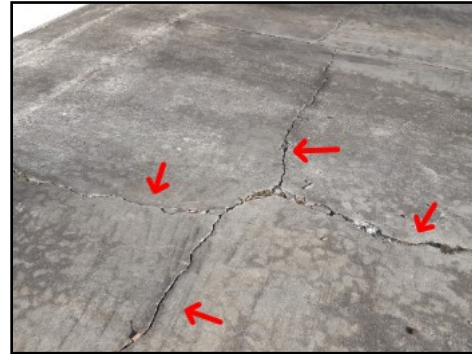
- Driveway flatwork panels are cracked at various locations at the time of the inspection.

Cracks in driveway flatwork

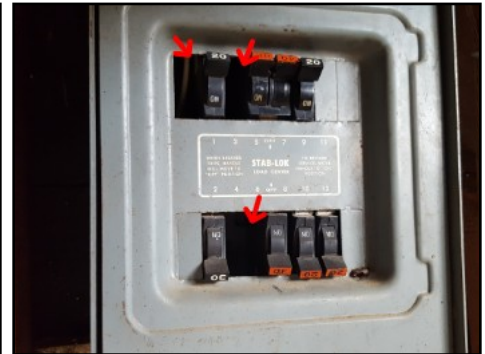
Missing knock outs/caps

- Recommend a complete system evaluation and repairs made by a licensed Electrician prior to closing on the home.

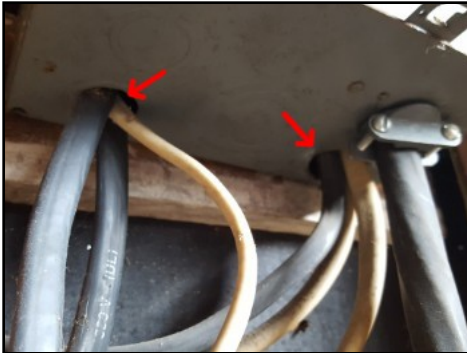
Missing protective grommet

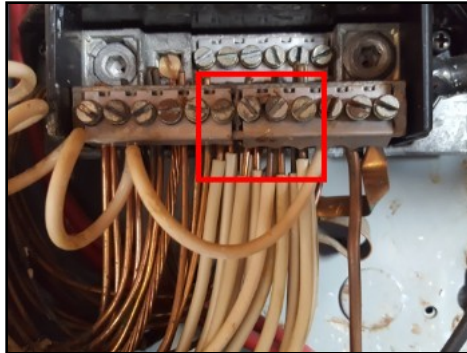
Double tapped neutral wires

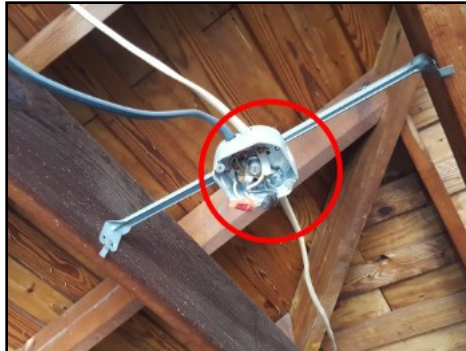
Missing junction box cover in garage

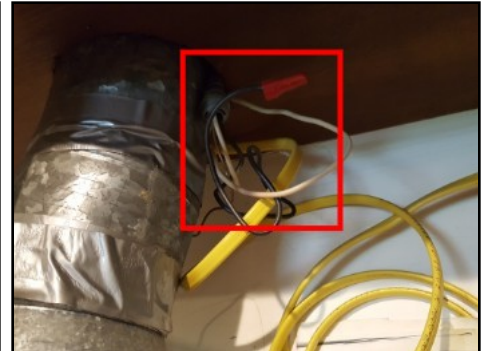
Wire connection missing junction box

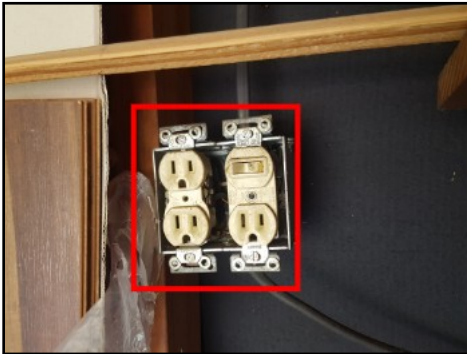
Missing cover plate in garage

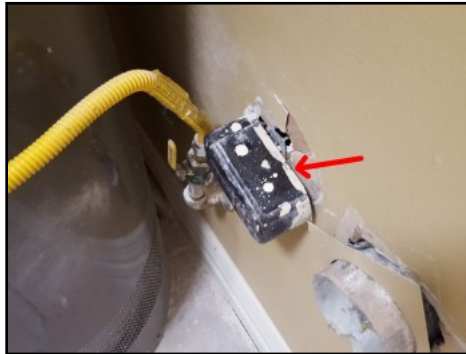
220 receptacle not secure in place

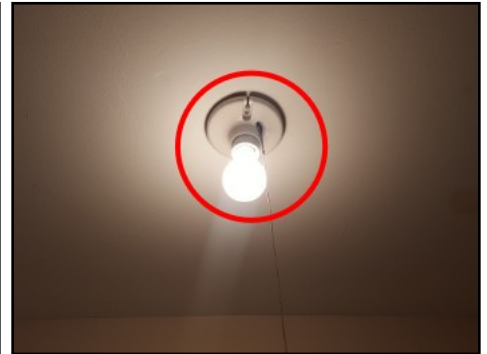
Missing light fixture protective globe

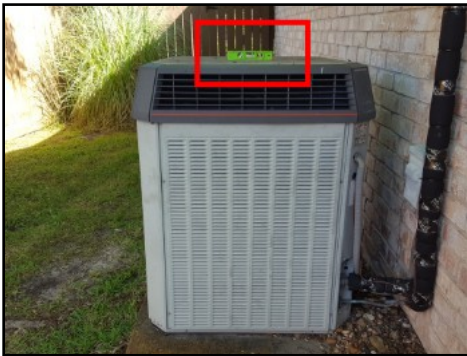
• **The A/C condensing unit is not level at the time of the inspection. This condition can affect compressor operation, lubrication and may place excessive stress on the freon lines and connections.**

Condensing unit not level

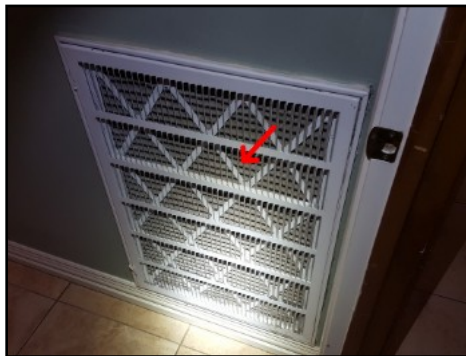
- **\*Visually inspected the accessible areas of the HVAC ductwork only.**
- **Air filter is dirty at the time of inspection and may be straining the system. Recommend replacing air filters prior to moving in and as required/needed.**

Dirty HVAC air filter

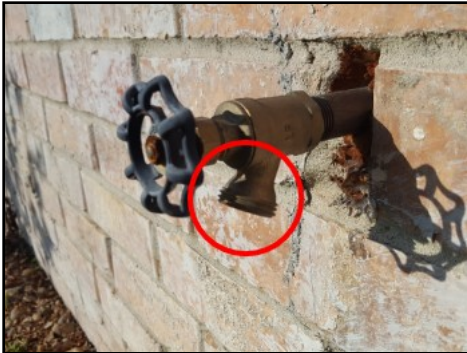
- **Missing back flow preventer at exterior hose bibs at the time of the inspection. Today's standards require Anti-siphon devices (back flow preventer) installed on all exterior hose bibs. Check all.**

Missing back flow preventer at hose bibs

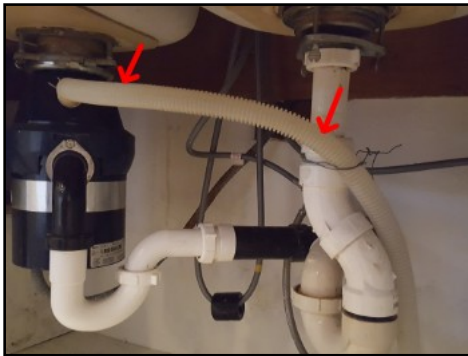
- Dishwasher = Bosch
- model# = SHE4AM16UC/01
- serial# = FD8804 01114
- Dishwasher functioned as intended at the time of the inspection. Dishwasher was ran through a complete cycle and leaks were not present. Recommend following the manufacture care and maintenance instructions.
- Dishwasher is not properly secure to the cabinet at the time of the inspection. Securing hardware is either loose and/or missing at the time of the inspection.
- Air gap is not present at dishwasher drain line prior to termination at food waste disposal. Recommend adding a "high loop" to the dishwasher line.

Dishwasher drain line missing high loop

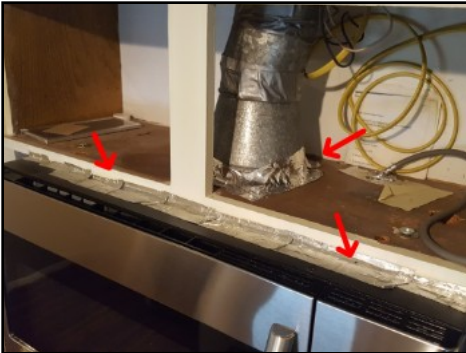
Seal microwave/duct through cabinet

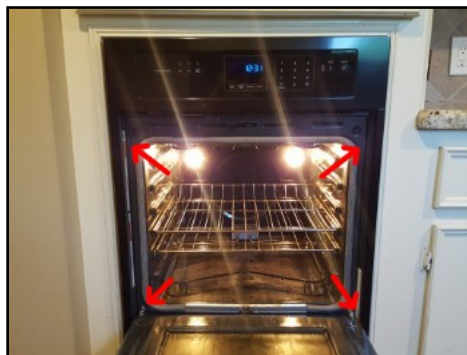
- **Oven = Whirlpool**
- **model# = WOS11EM4EB00**
- **serial# = D73712960**
- **The Oven is electric.**
- **Oven operated normally at the time of the inspection. Oven was set to 350 degrees and temperature accuracy was within 25 degrees. Recommend following the manufacture care and maintenance instructions.**
- **Cooktop = Frigidaire**
- **model# = FEC36SEB1**
- **serial# = HZ84101636**
- **The Cooktop is electric.**
- **The cooktop functioned as intended at the time of the inspection. Recommend following the manufacture care and maintenance instructions.**
- **Oven is not properly secure in place at the time of the inspection.**

Oven not secure in place

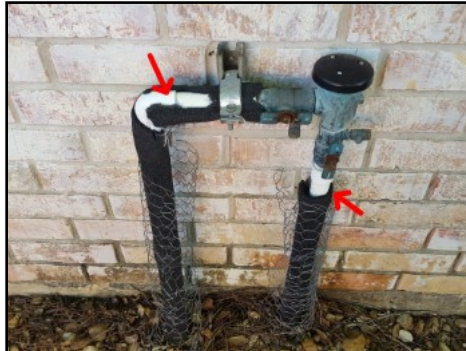
Irrigation pipe insulation damaged/missing
