## Property Inspection Report

1234 Texas Cir., Tomball, TX 77377

Date of Inspection: 1/2/2020 Time: 8:00 AM

Inspector: Travis Kepp

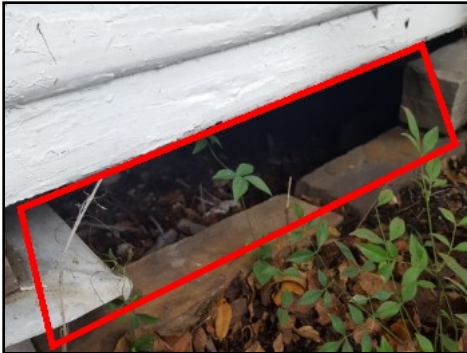
- **Proper crawl space skirt is not present at various locations of the foundation at the time of the inspection. Skirt is installed to keep vermin, pests, and/or wild animals from entering within the crawlspace. Current industry standard is 1 square foot of ventilation for every 1500 square feet of crawl space. Check all.**

Skirt/cover not present at crawlspace

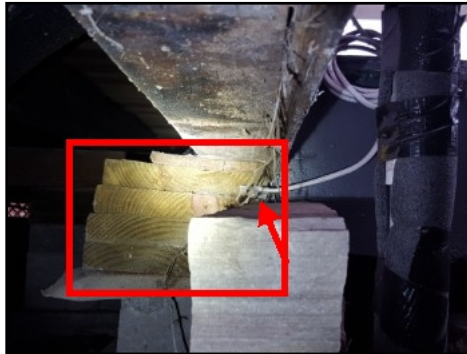
- **Observed altered floor beam that was not properly scabbed/supported within the crawlspace at the time of the inspection. Check all.**

Inadequate beam support at front elevation

- **Recommend further evaluation by a Texas Professional Structural Engineer and/or pier and beam specialist to go over repairs and cost of repairs prior to closing on the home based on the findings at the time of the inspection.**

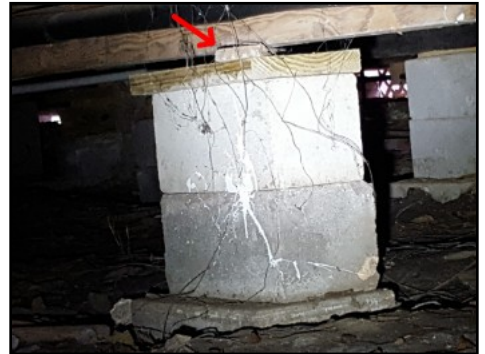
Inadequate beam support within crawlspace

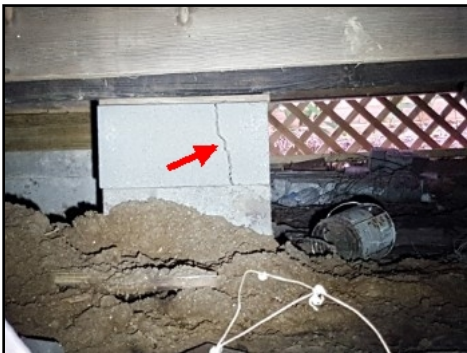
- **Inspector observed piers at various locations that were leaning and/or were not properly supporting load bearing material/beams. Cracked pier material present within the middle front of the crawlspace at the time of the inspection. Check all.**

Pier material cracked within crawlspace

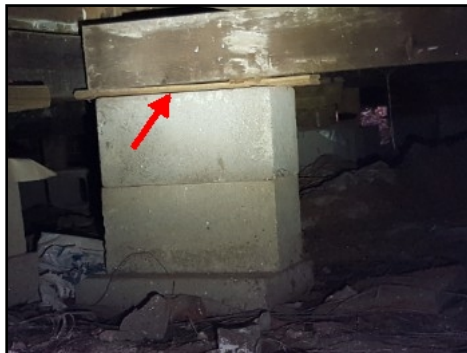
Termite shield not present

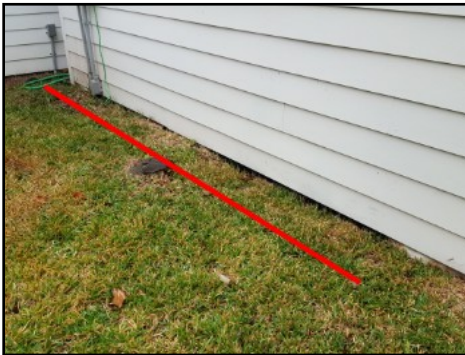
High grading at rear elevation

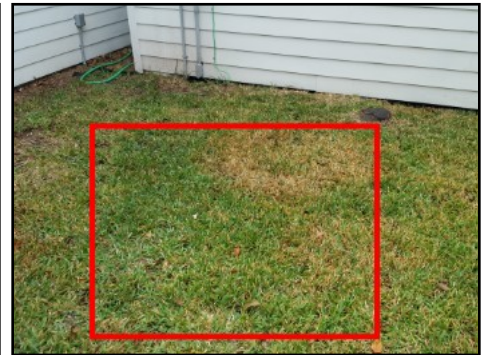
- **Excessive moisture and/or standing water was observed at the rear left of the property at the time of the inspection. The grading should promote the flow of storm water away from the foundation and off the lot in a timely manner. Some options might be but not limited to: additional gutters, improved swale, surface drains, french drains, or sub surface drains.**

Excessive moisture at rear left elevation

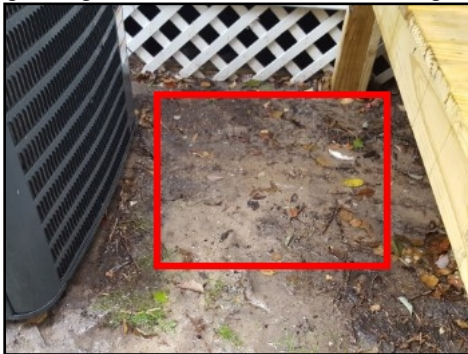
Excessive moisture at rear left elevation

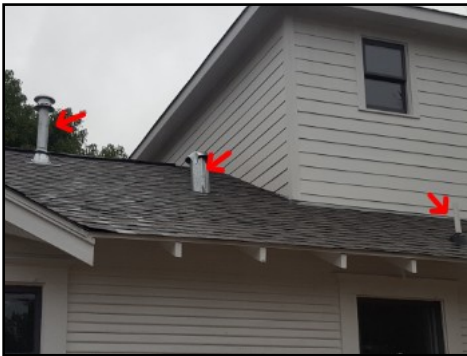
- **Vent pipes, roof jacks, and/or flashing material are not painted at the roof covering of the home at the time of the inspection. Recommend ensuring the securing nails are sealed prior to painting. Painting these help protect them from the exterior elements. Check all.**

Vents/roof jacks not painted at right elevation

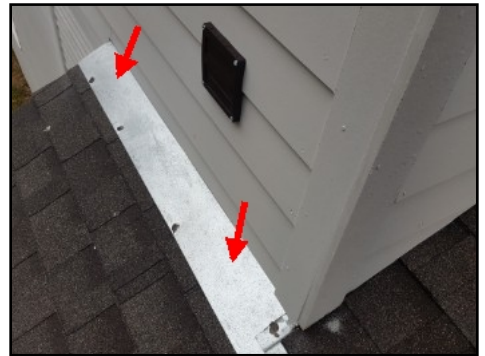
Flashing not painted

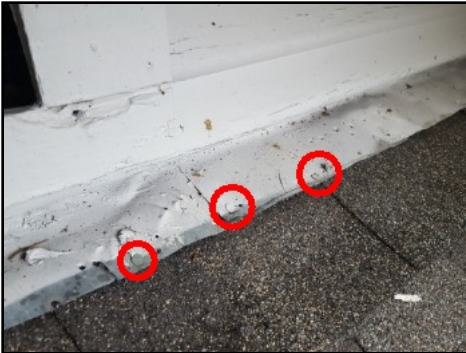
- **Observed several exposed shingle nails, flashing nails, and/or roof jack nails that should be sealed so not to allow moisture entry to home. Recommend securing and sealing all nail heads that penetrate through the roof covering and/or flashing material. Check all.**

Exposed nails at roof covering

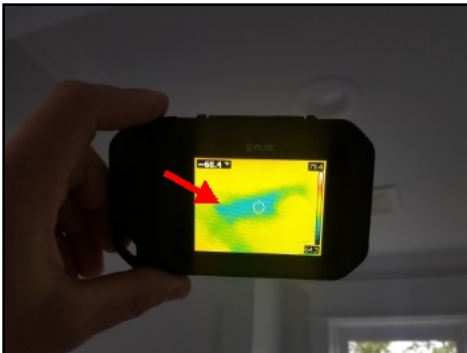
Evidence of poor insulation at master bath

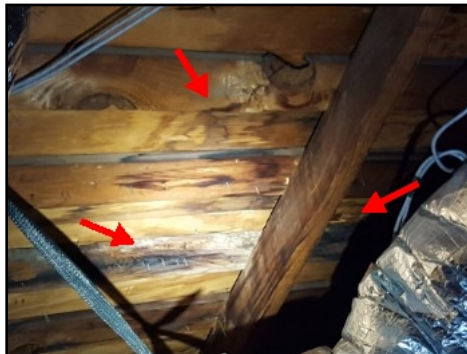
Moisture stains present at attic deck/lumber

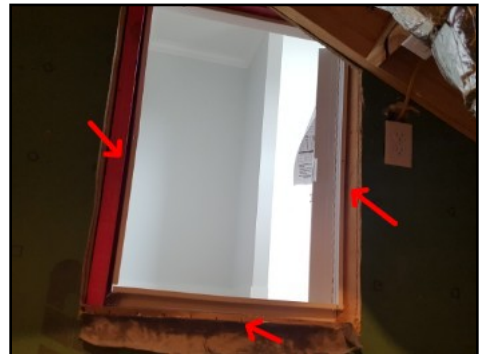
Attic door jamb not foam sealed

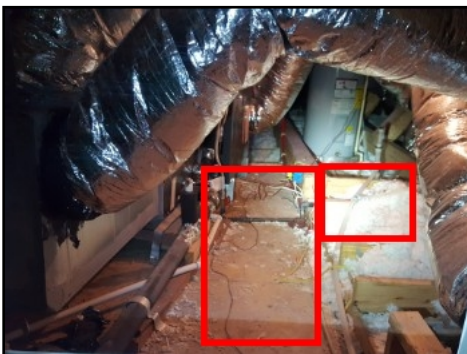
Improper walkway/landing in attic space

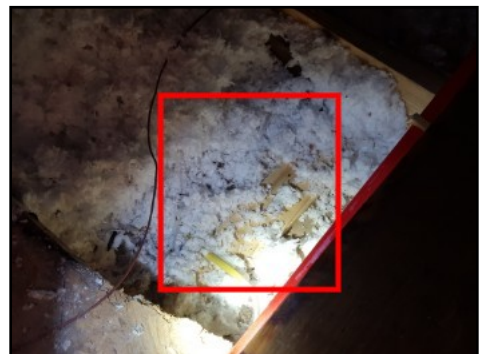
Compressed/missing insulation

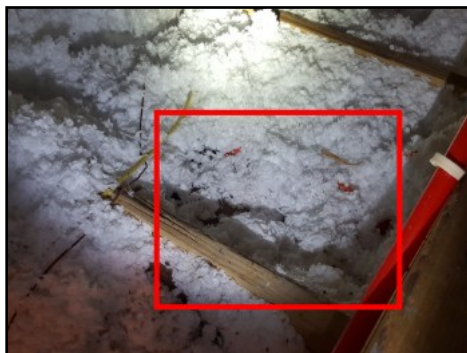
Compressed/missing insulation

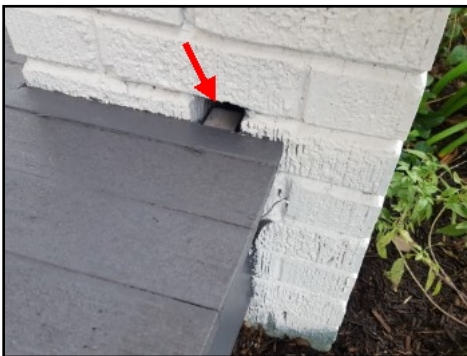
Seal material intersections

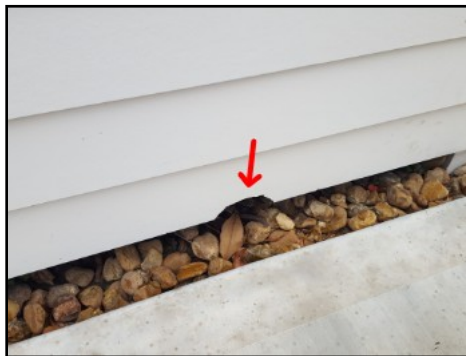
Damaged siding material at rear right elevation

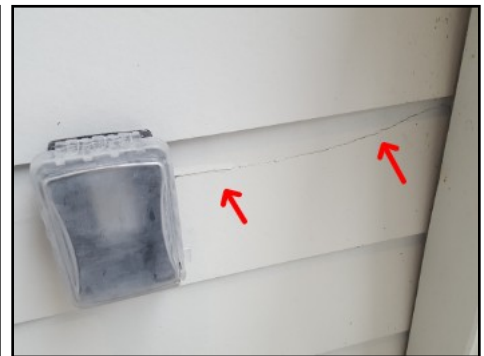
Damaged/cracked siding material at rear elevation

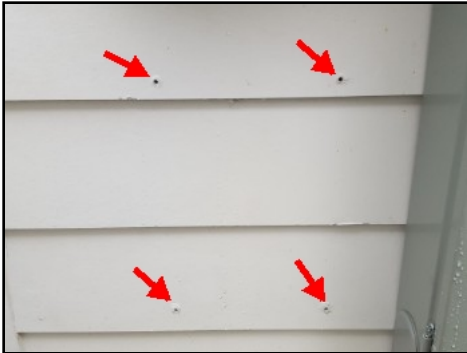
Seal holes in siding at rear left elevation

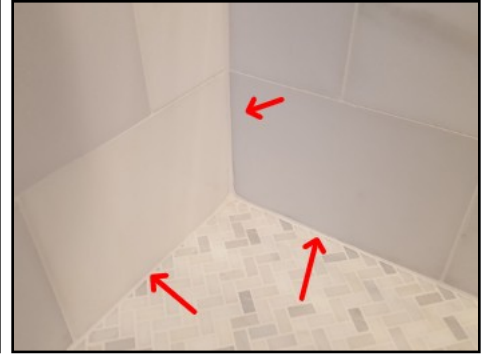
- Seal all corners of shower tile and where tile meets tub/shower pan as needed. Recommend sealing around all plumbing fixtures in showers and tubs. Check all.

Seal shower corners/Intersections

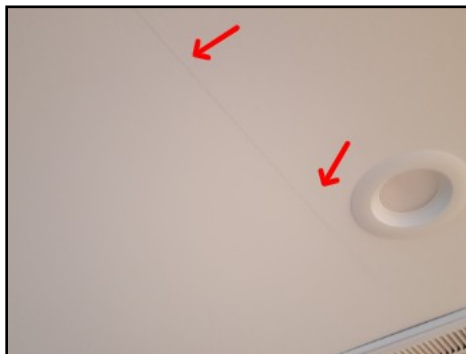
- **Minor drywall repair and paint touch ups needed at the ceiling throughout the home. Check all.**

Settling crack at living room ceiling

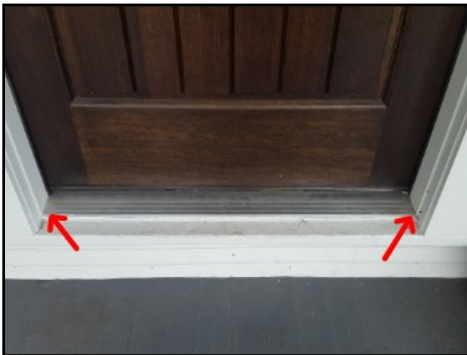
Seal door thresholds/jambs

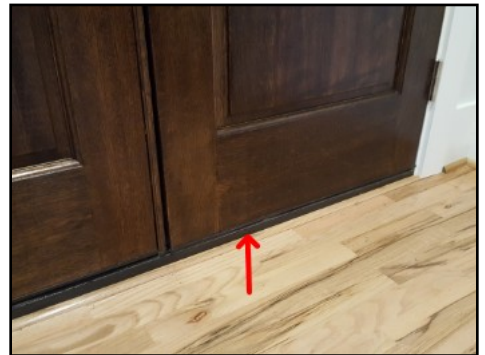
Door rubs on threshold

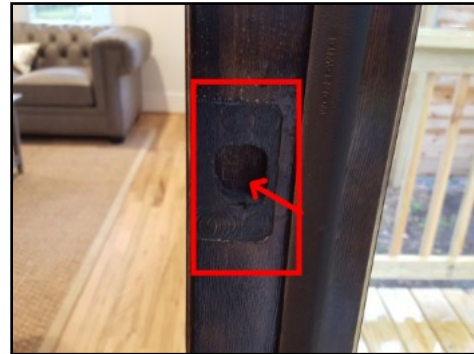
Missing strike plate/bore deadbolt hole

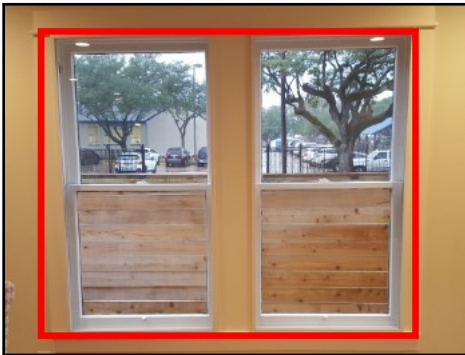
Windows blocked at lower level

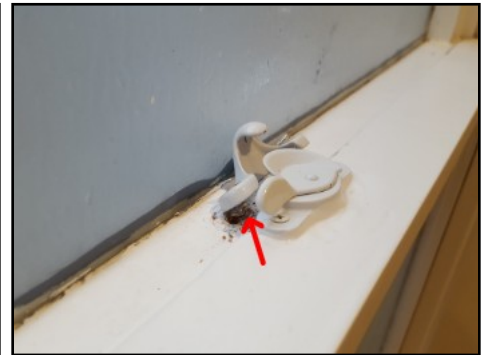
Latch housing not secure in place

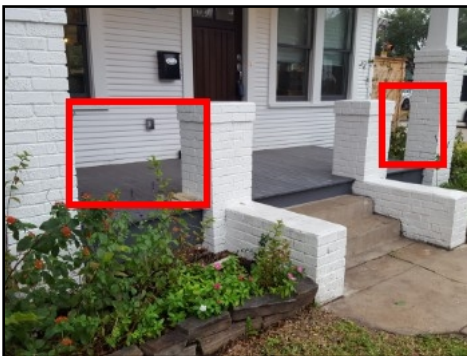
Railing not present

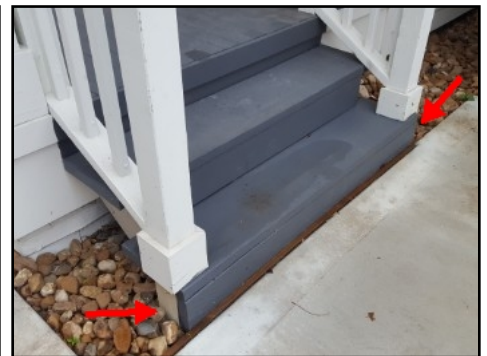
Rear porch material in contact with grade

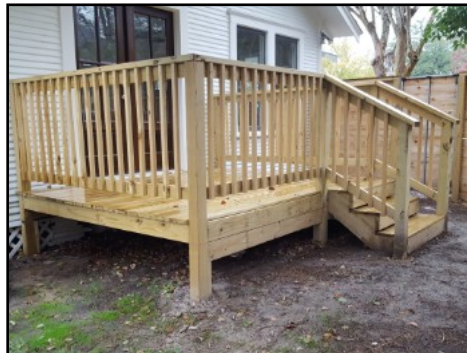
Rear deck not stained/painted

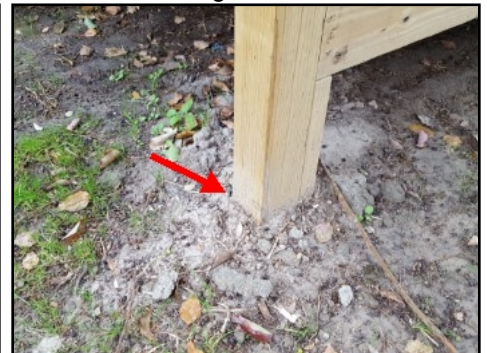
Post in contact with grade/soil

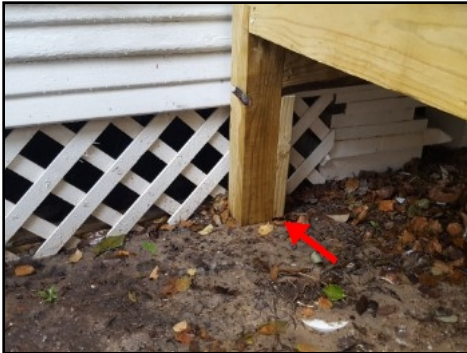
Post material in contact with grade/soil

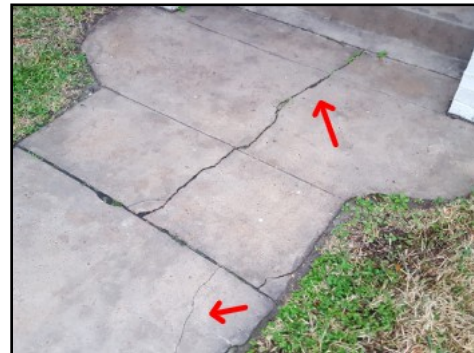
• **Front elevation walkway flatwork panels are cracked at various locations at the time of the inspection. Check all.**

Cracks in walkway flatwork

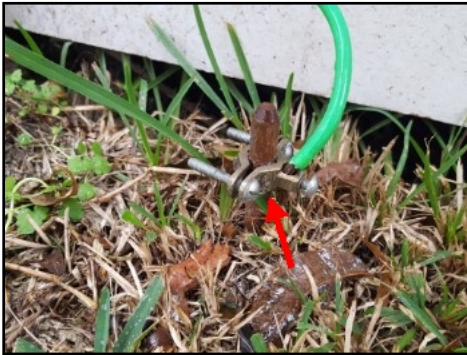
Incorrect ground clamp

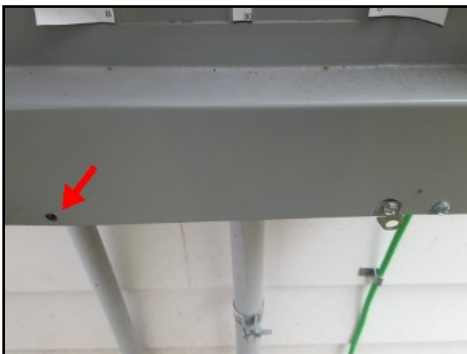
Missing blunt screw

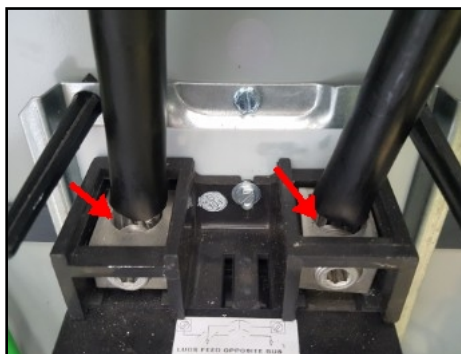
Aluminum wires missing antioxidant gel

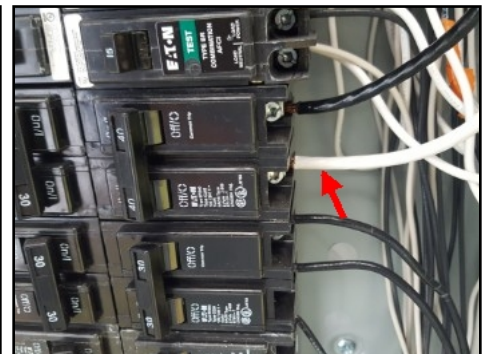
White "hot" wires not marked with tape

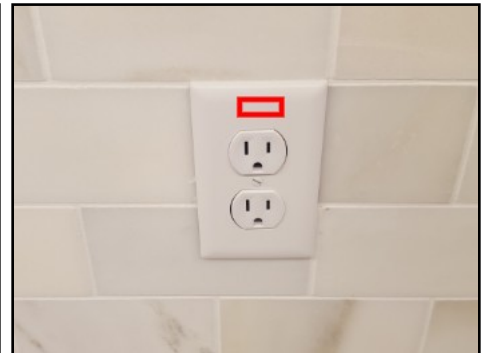
Missing sticker at GFCI receptacles

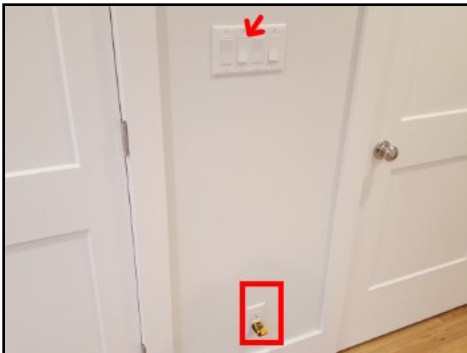
Receptacle operated by switch

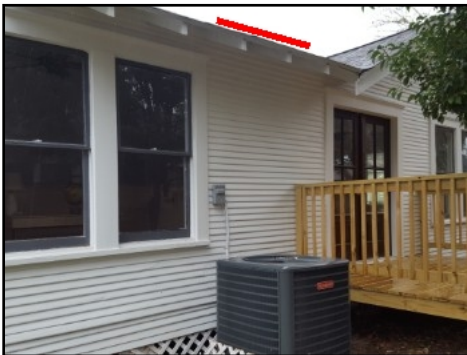
Recommend splash guard over condensing unit

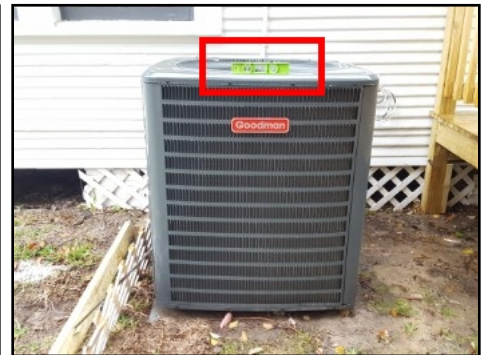
Condensing unit not level

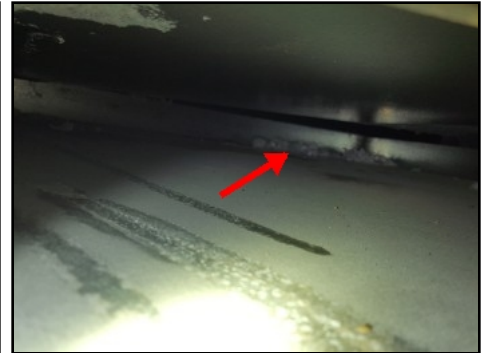
Debris in secondary A/C drain pan

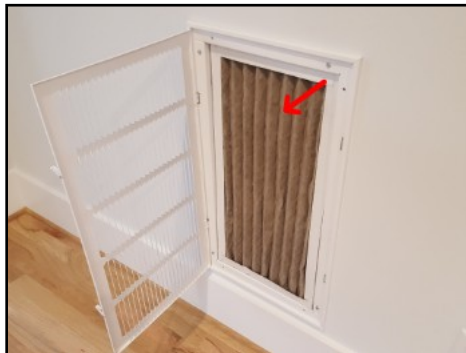
- **\*Visually inspected the accessible areas of the HVAC ductwork only.**
- **Air filters are dirty at the time of inspection and may be straining the system. Recommend replacing air filters prior to moving in and as required/needed. Check all.**

HVAC filter dirty

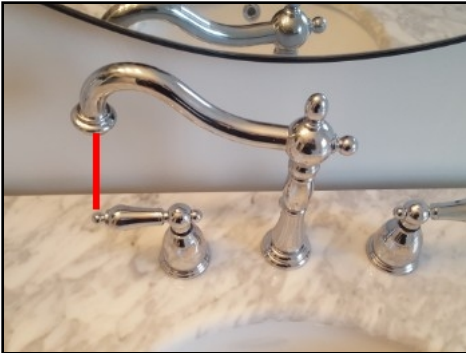
Swing stop not present

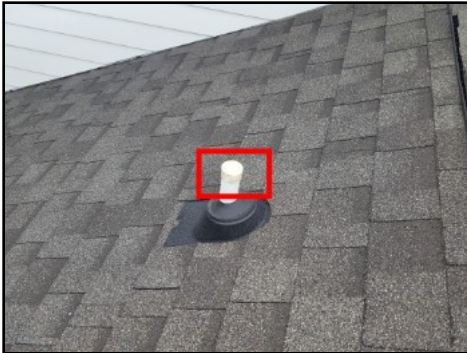
Stack vent capped/covered

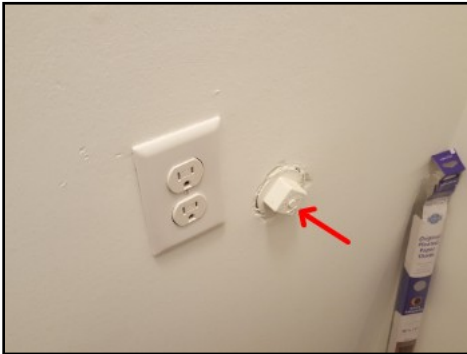
Recommend flush mount cover

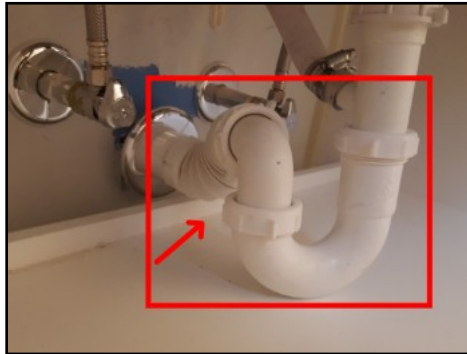
S-trap present at powder bathroom vanity

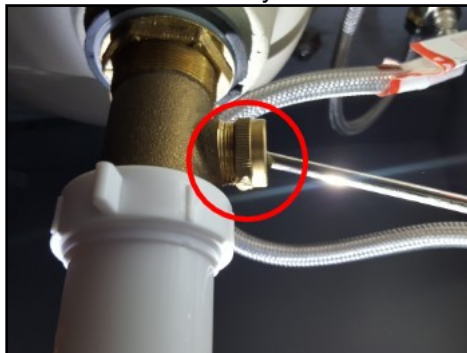
Leak at lower bathroom vanity drain stop

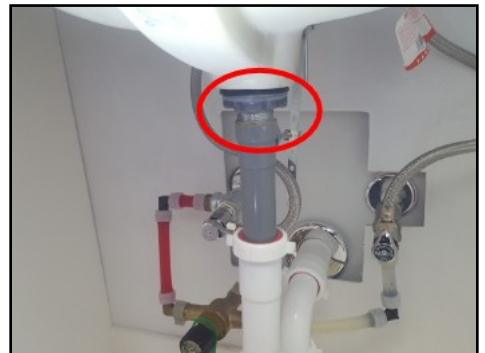
Leak present at master bathroom vanity drain

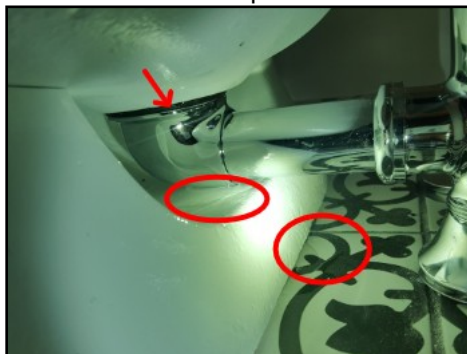
Lek at master bathroom tub drain

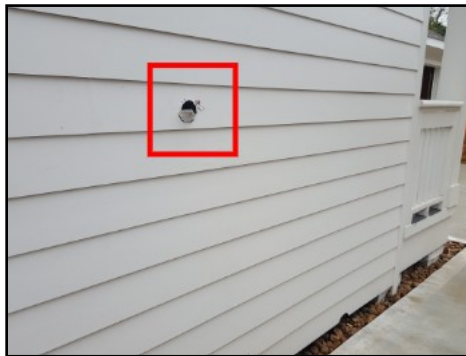
Vent cover not present/Seal exterior penetrations
