Property Inspection Report

1234 Texas Ave., Cypress, TX 77433 Inspection prepared for: John Doe Real Estate Agent: -

Date of Inspection: 1/21/2020 Time: 8:30 AM Age of Home: 2020 Size: 4400 sqft Weather: Sunny

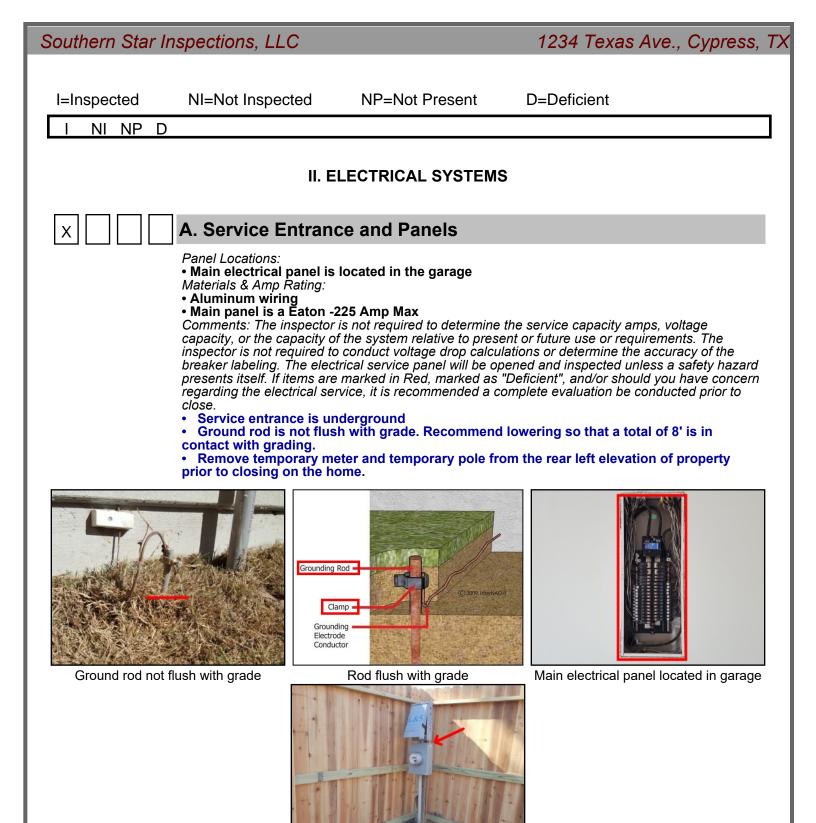
Remove temporary meter and pole

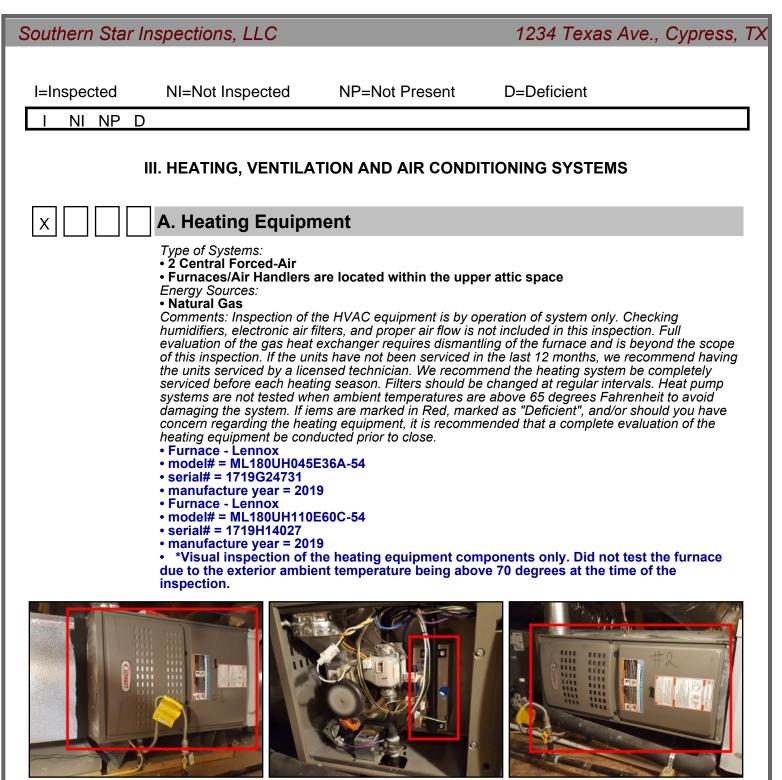
Furnace/Air handler located in upper attic space

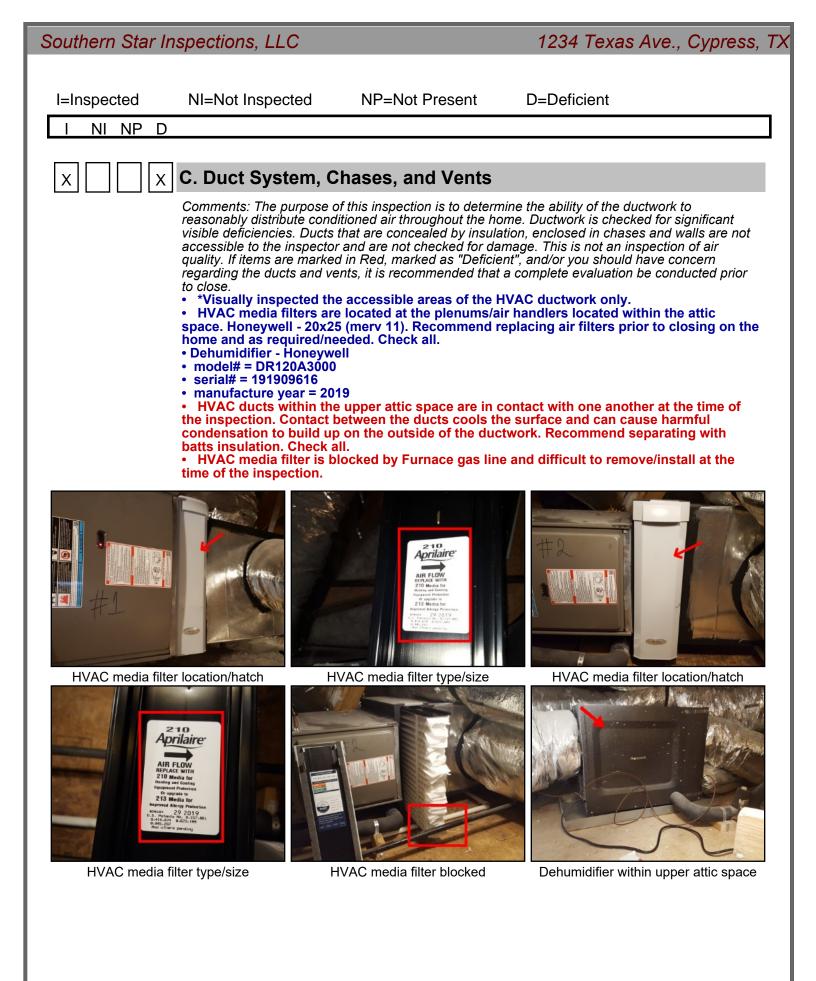
HVAC duct work in contact with one another

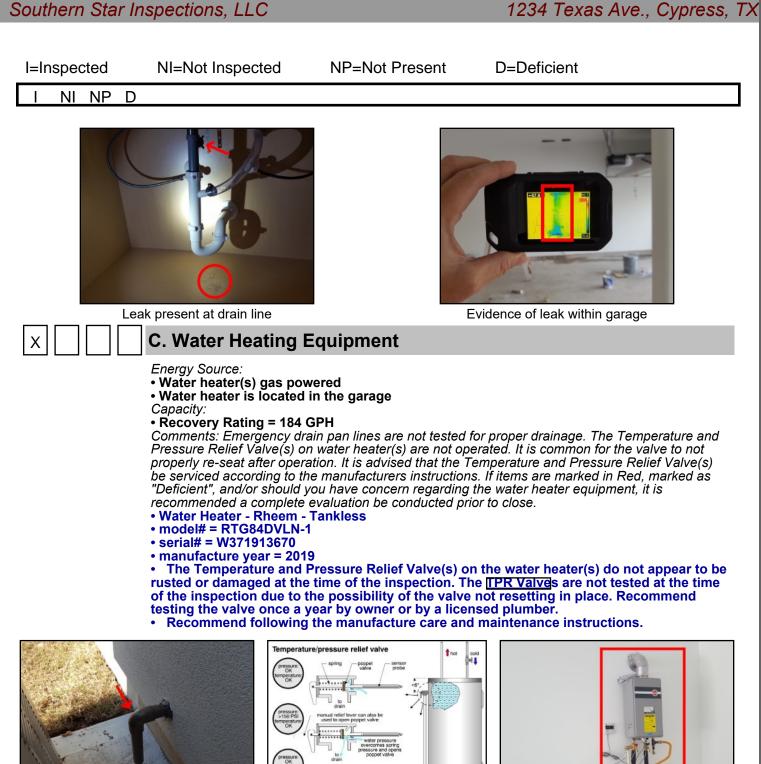
Drain line termination at rear left elevation
