# Southern Star Inspections, LLC

## Property Inspection Report

1234 Texas Dr., Pinehurst, TX 77362

Date of Inspection: 2/3/2020 Time: 8:30 AM

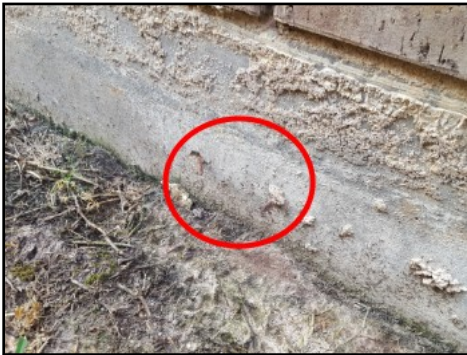
- **Remove nails from foundation walls. Nails present at the foundation wall are either from the tension cables or brick layers. Check all.**

Remove nails from foundation wall

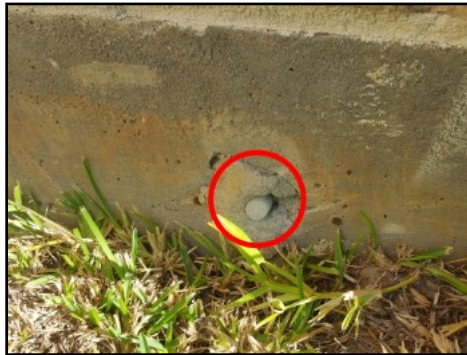
- **Post tension cable is not properly sealed at the left and rear left elevation foundation wall. It is recommended to seal/patch this with a non shrinking epoxy grout to prevent corrosion of cables. Check all.**

Exposed tension cable at left elevation

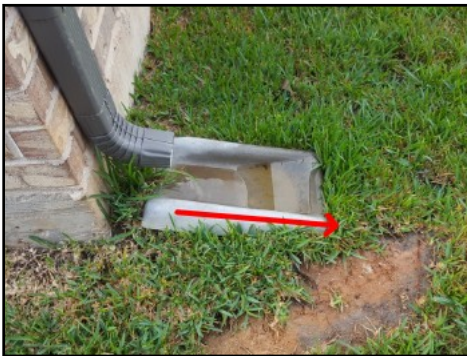
- **Recommend open end of splash block be placed away from the home to deter standing water. Check all.**
- **Subsurface and/or french drains are not present at time of inspection.**

Open end away from structure

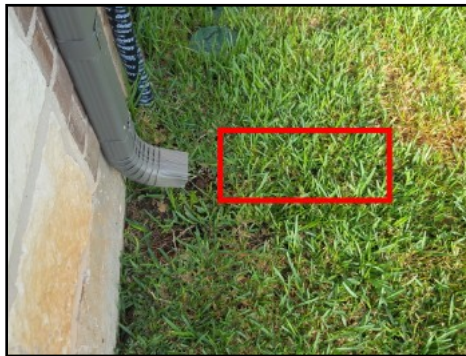
- **Missing splash blocks at the gutter down spouts at various locations of the home at the time of the inspection. Check all.**
- **Evidence of excessive moisture and/or standing water was observed at the rear right and rear left of the property at the time of the inspection. The grading should promote the flow of storm water away from the foundation and off the lot in a timely manner. Some options might be but not limited to: additional gutters, improved swale, surface drains, french drains, or sub surface drains.**

Missing splash block

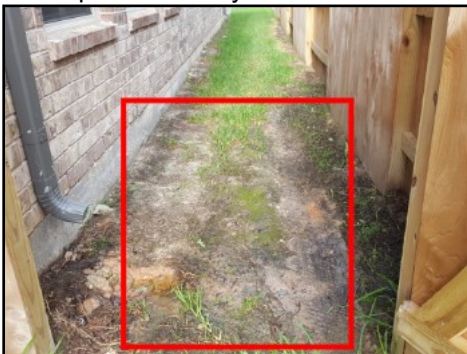
Evidence of excessive moisture

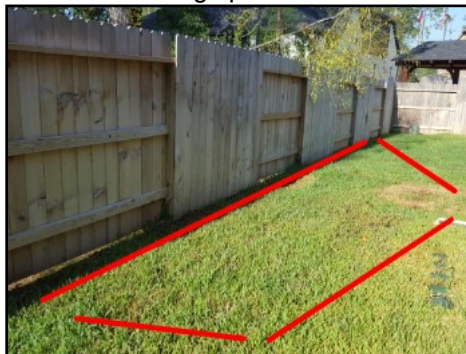
Excessive moisture at rear left elevation

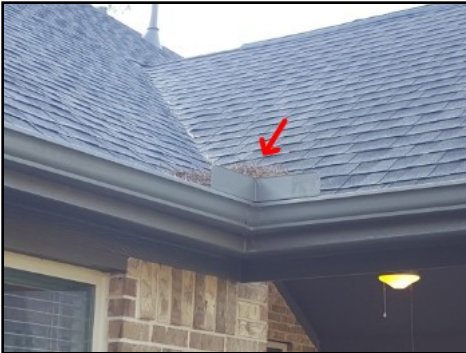
- **Gutters have debris that can possibly clog the gutter down spout and cause moisture penetration. Recommend periodically cleaning all gutters so that water is diverted away from structure as intended.**

Debris in gutters

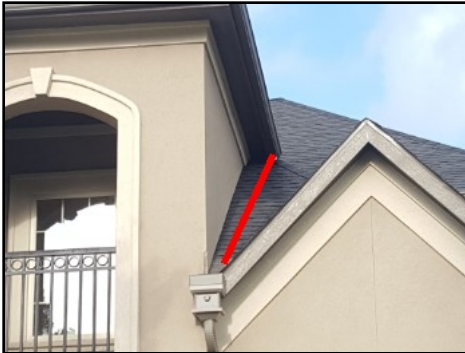
- Recommend extending gutter downspouts from the upper roof line to the lower gutter system so shingles do not become prematurely worn in these areas. Check all.

Gutter extension recommended

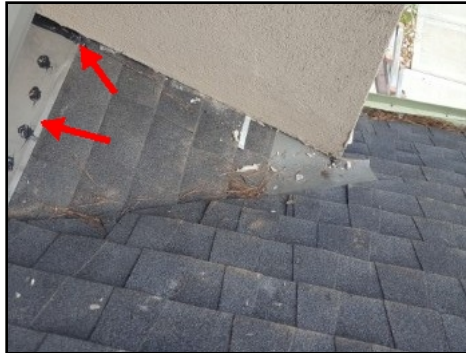
- Evidence of fresh sealant is present at the front elevation of the roof covering, over garage area that has signs of moisture intrusion. Recommend consulting with builder regarding previous leaks and/or repairs made to the roof covering and if leak test was conducted at this area.

Fresh sealant at front elevation (over front garage)

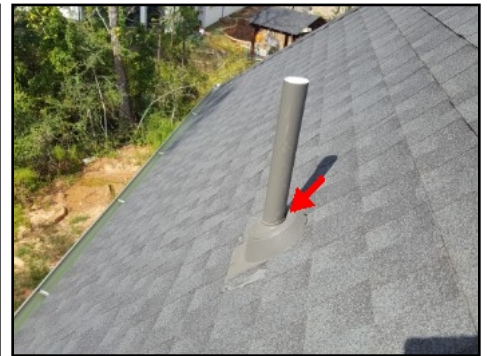
- Observed vegetation debris such as leaves and/or pine needles on the roof covering that should be removed as needed. Check all.
- Polyurethane roof jacks are buckled at various locations of the roof covering at the time of the inspection. Buckled roof jacks can hold water and cause deterioration/leaks. Check all.

Buckled roof jacks at rear left elevation

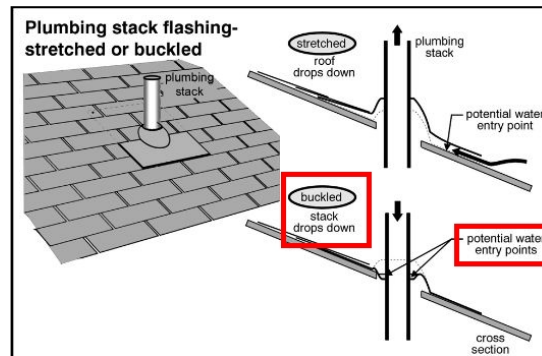
Example of buckled roof jacks

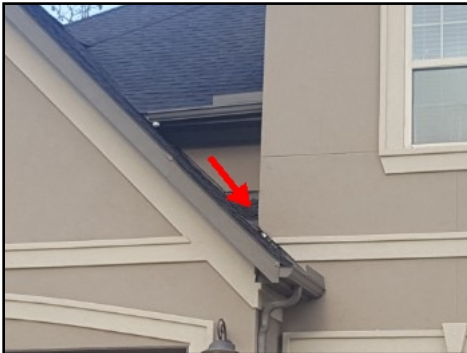
Monitor "trap" area in roof design

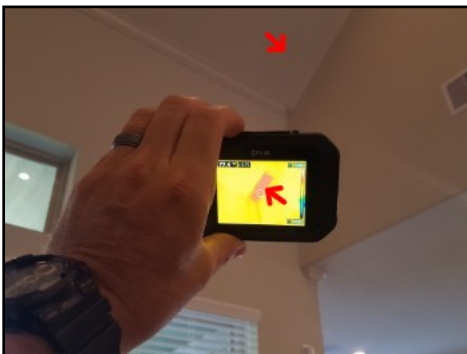
- **Several pieces of batts insulation were missing and/or not properly secure in place within the attic space. Replacing missing insulation so that all areas have an equal R-value has proven to save energy. Check all.**

Missing batts insulation at living room ceiling

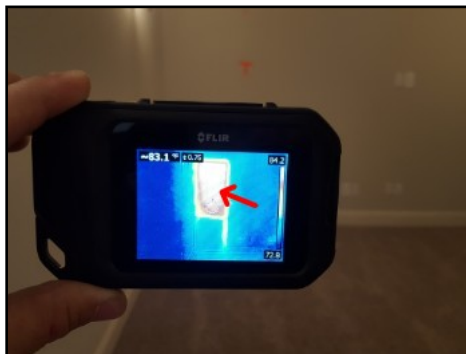
Insulation not present over scuttle door

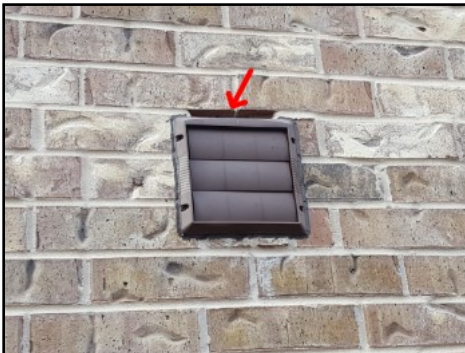
- Seal around all gaps of electrical and/or plumbing penetrations through exterior walls to deter moisture and insect intrusion. Some areas include but not limited to: exterior light fixtures, electrical outlets, hose bibs, plumbing clean outs, vent terminations, gas lines, and A/C refrigerant lines. Check all.

Seal all exterior penetrations

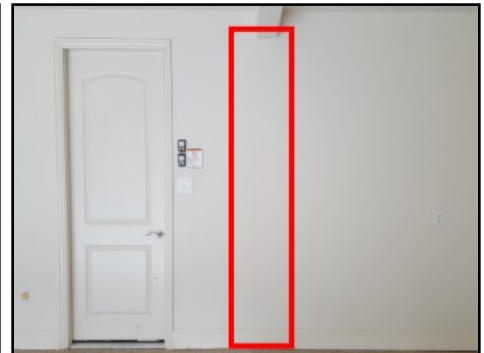
- Moisture stains and damage is present at the garage walls and load bearing beam. Higher than normal moisture reading is present at these locations at the time of the inspection. It is recommended to consult with the builder regarding previous leaks/repairs made in this area and if leak test was conducted. Observed what appears to be mildew growth at lower baseboard. Recommend removing drywall/insulation and cleaning this area with a mixture of bleach and water and allowing to air dry. Monitor for future leaks and/or growth of mildew. If mildew surfaces it is recommended to contact the builder and a mildew/mold specialist.

Moisture stains/damage present

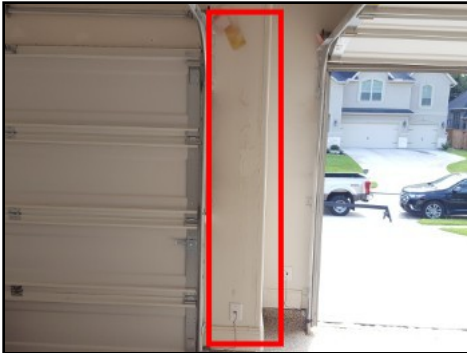
Moisture stains/damage present

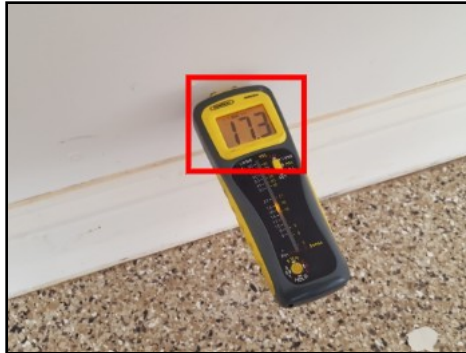
Higher than normal moisture reading present

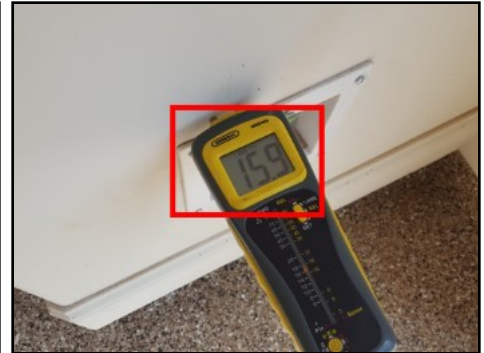
Higher than normal moisture reading present

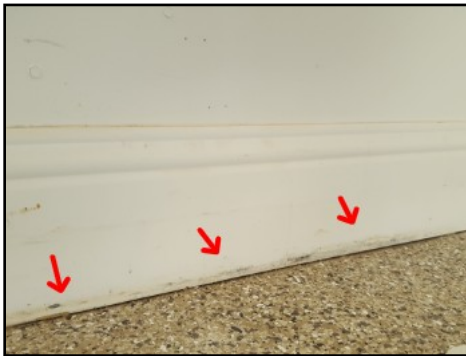
Possible mildew growth at garage baseboard

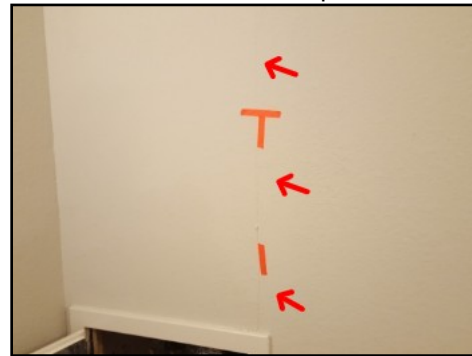
Settling crack at media room

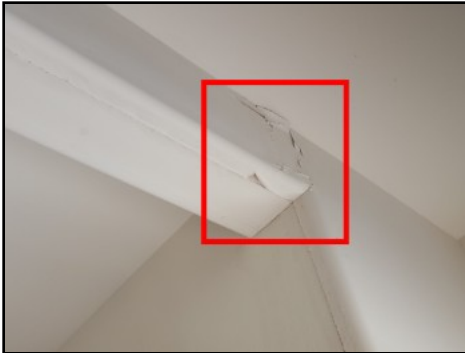
Moisture stains/damage present

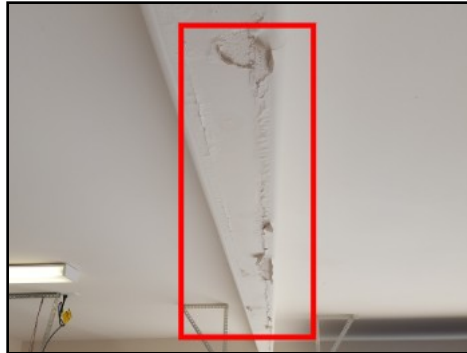
Moisture stains/damage present

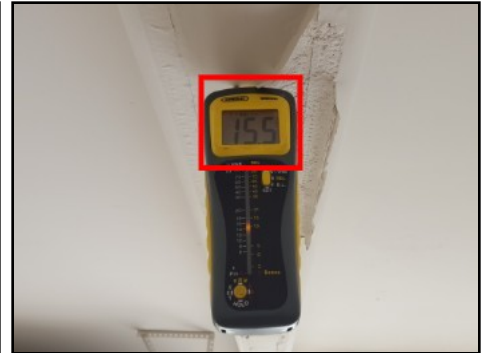
Higher than normal moisture reading present

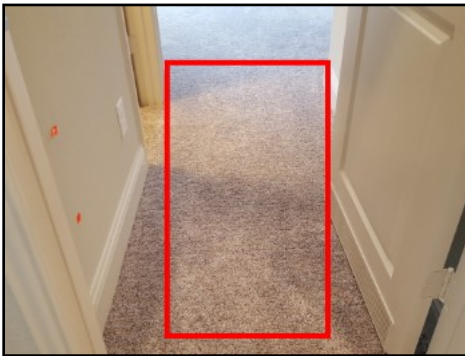
Floor pops/squeaks present

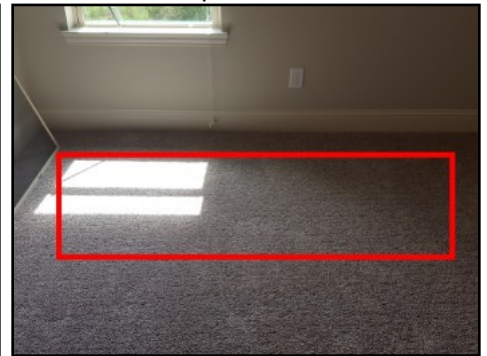
Floor pops/squeaks present

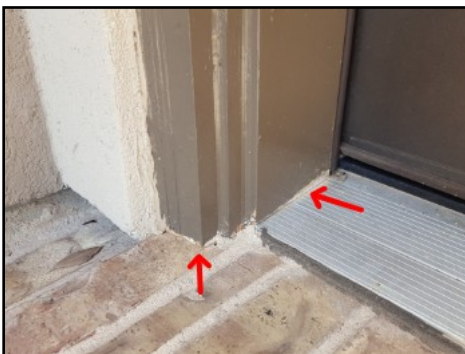
Seal door thresholds/jambs

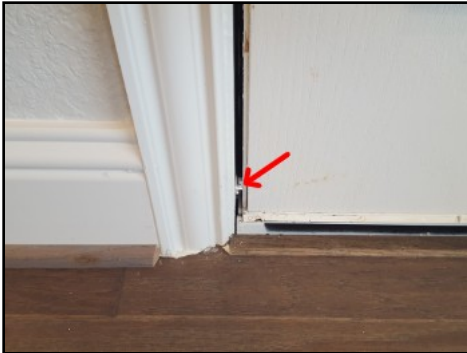
Gap at lower strike side

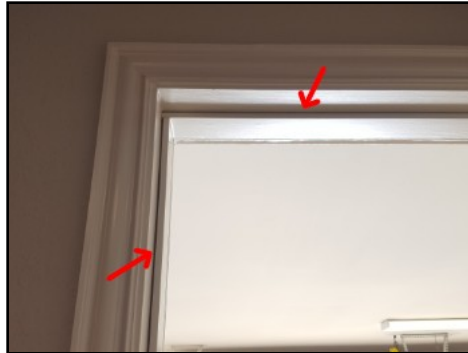
Missing weatherstripping at garage door

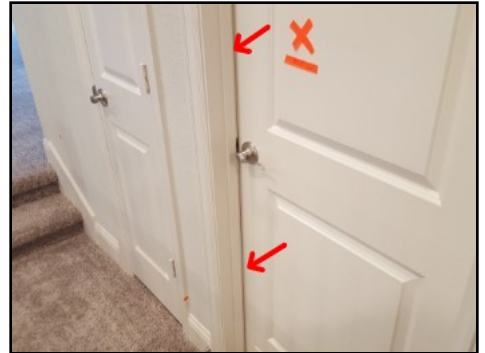
Door rubs on frame/jamb

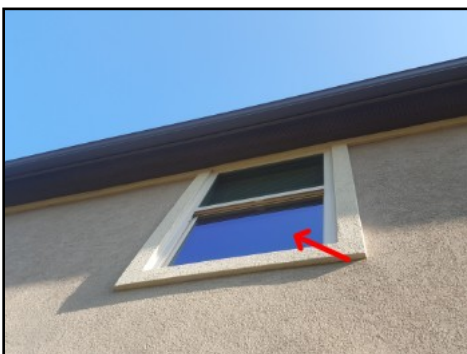
Missing screen at rear left elevation

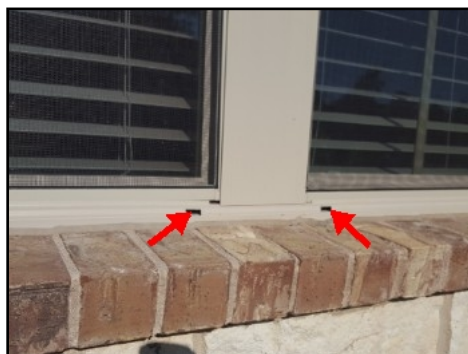
Missing weep hole covers at front elevation

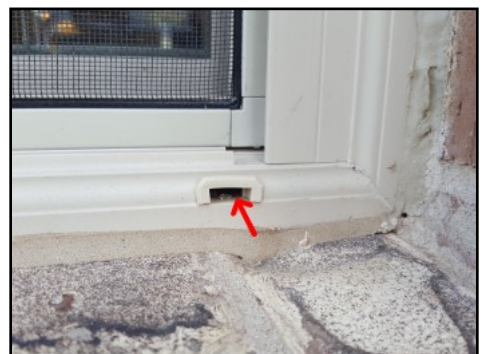
Damaged weep hole cover at rear elevation

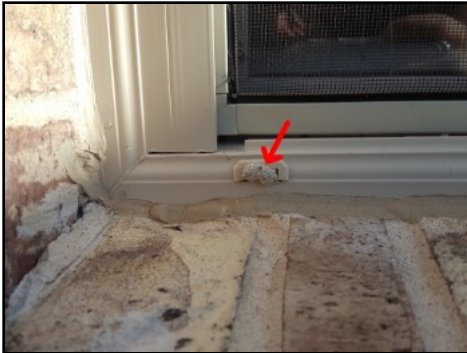
Blocked weep hole cover at rear left elevation

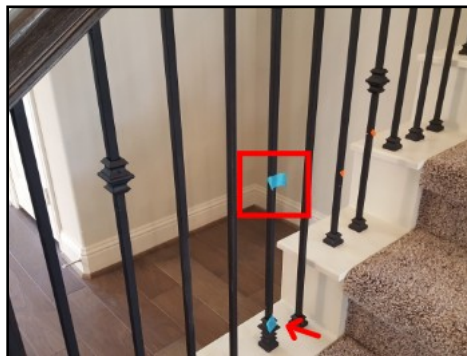
Staircase spindle base not in correct space

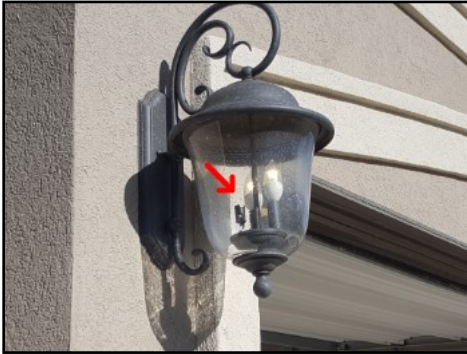
Light bulb missing at coach light

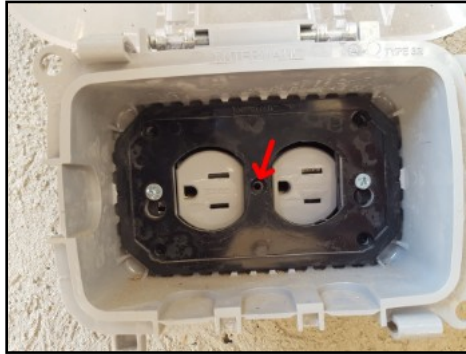
Front porch receptacle not secure

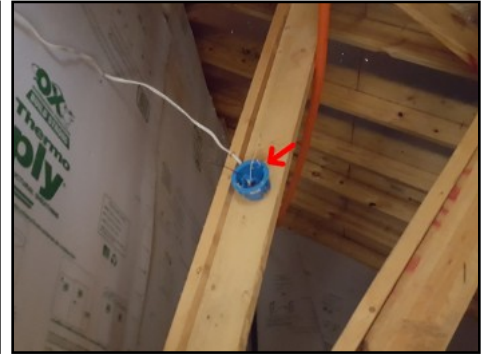
• **Light fixture/bulb is not present at the lower front attic space (over garage) at the time of the inspection.**

Light fixture/bulb missing

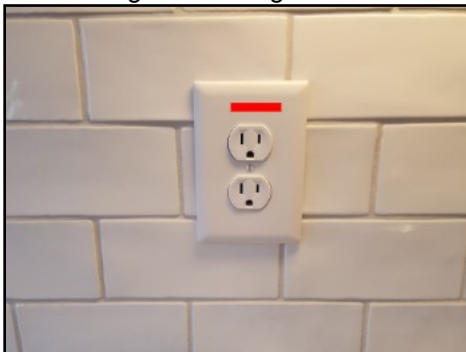
Missing sticker at GFCI receptacles

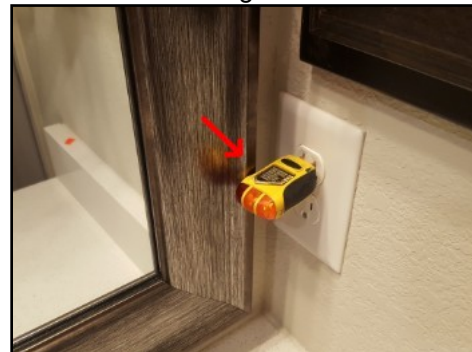
• **Upstairs hallway bathroom receptacle is partially blocked by mirror frame making it difficult to properly access.**

Receptacle blocked by mirror frame

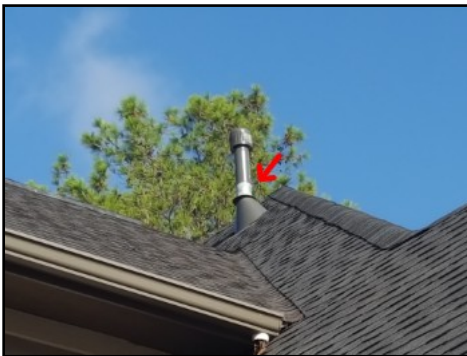
- Furnace vent pipe and storm collar is not painted at the roof covering of the home. Recommend ensuring the storm collar and roof jack nails are sealed before painting. Painting the vent material helps protect from oxidation/rust.

Vent pipe not painted

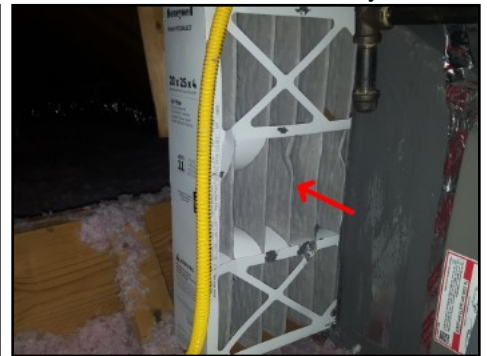
HVAC media filter dirty

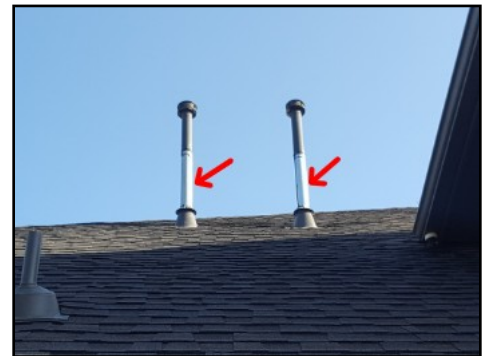
Vent pipes not painted

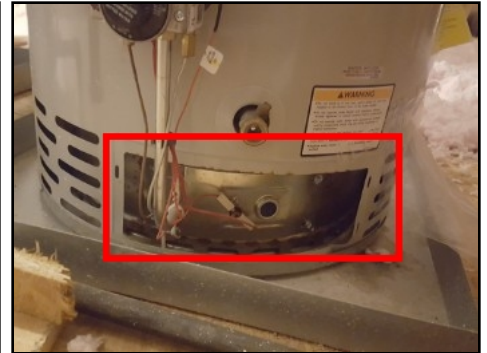
- Water heater burner covers are not present at the time of the inspection.

Burner covers not present

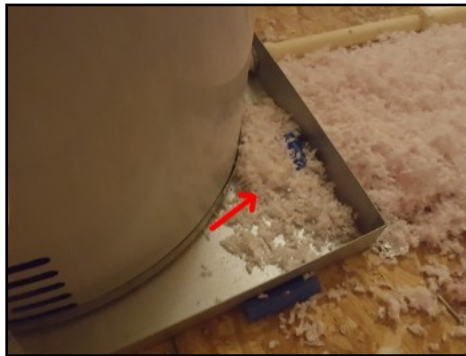
- Debris found in the water heater drain pan and should be removed so not to clog drain line. Check all.

Debris in water heater drain pan

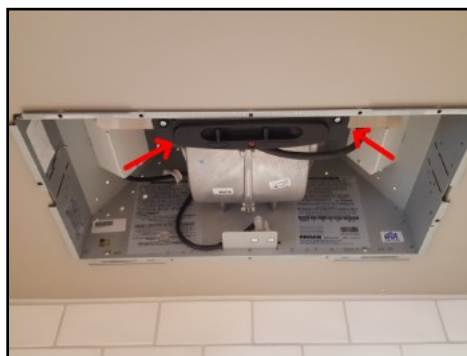
Light bulbs not present

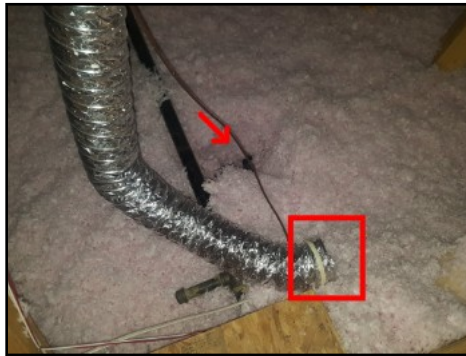
- Exhaust fans functioned as intended at the time of the inspection. Bathroom heaters were not present at the time of the inspection.
- Exhaust fan duct within the upper attic space is not properly secure to fan motor at the time of the inspection. All exhaust ducts should terminate to the exterior either through the roof covering or a sidewall. Check all.

Exhaust fan duct not connected

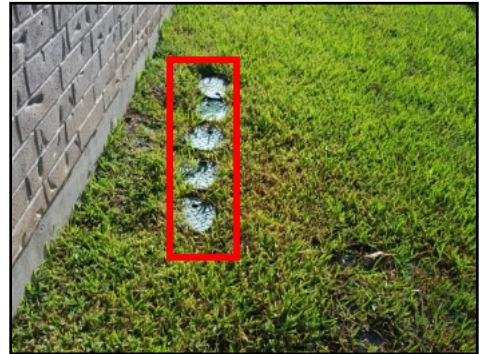
- **Possible leak present at the rear left elevation irrigation valves at the time of the inspection. Recommend complete system evaluation by a licensed technician prior to closing on the home. Check all.**

Possible leak at rear left valve
