Property Inspection Report

1234 Texas Parkway, The Woodlands, TX 77380 Inspection prepared for: Jane Doe Real Estate Agent: -

Date of Inspection: 12/12/2019 Time: 8:30 AM Age of Home: 2019 Size: 3256 sqft Weather: Sunny This is a Phase 1 home inspection following the TREC Standards of Practice.

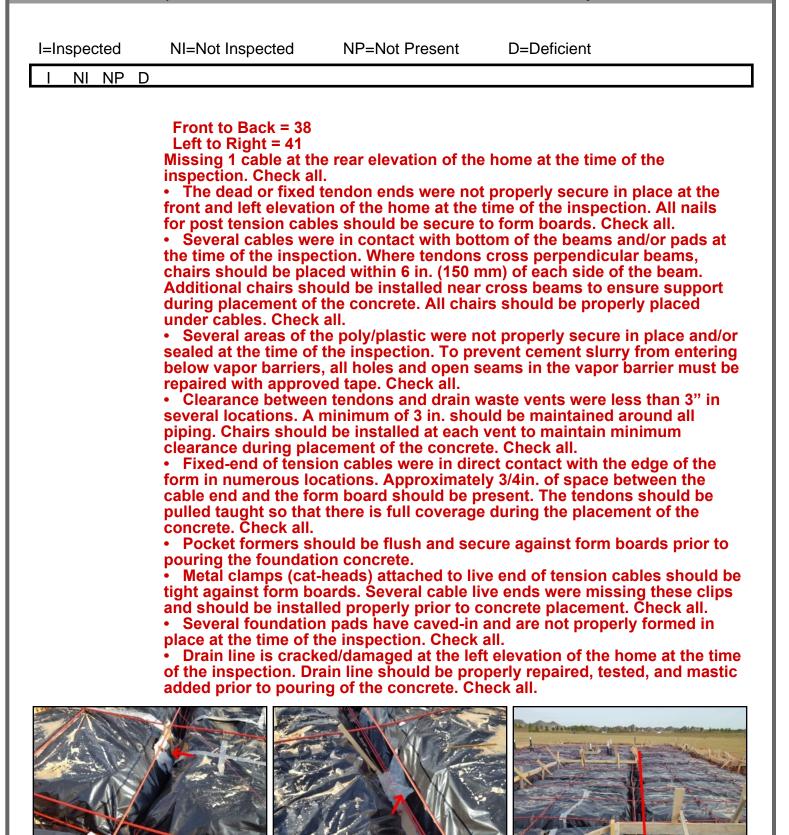
Remove all debris from within foundation

Missing cable at rear elevation
