Property Inspection Report

1234 New Street Cir., The Woodlands, TX 77380

This is a Pre-Drywall Phase 2 Inspection following the TREC Standards of Practice.
Client was present during the inspection for walk through and questions answered.

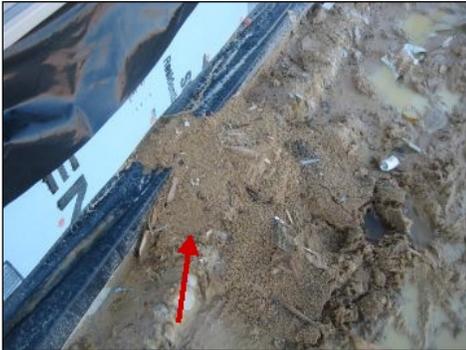
• Some areas of the foundation could not be inspected due to high soils and/or construction debris.

Foundation blocked at right elevation of home

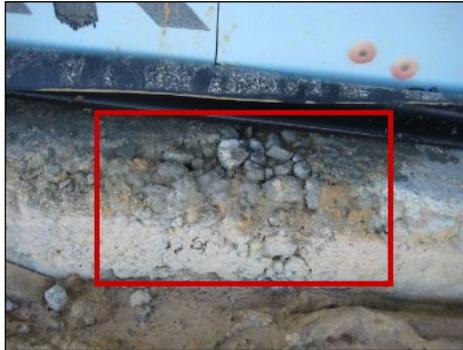
• Exposed aggregate or otherwise known as "Honeycombed" concrete was observed at several locations of the foundation. Areas include but are not limited to the front and left side of the garage door, right of front door, and the left elevation. Recommend patching/sealing these areas.

Exposed aggregate at right elevation of home

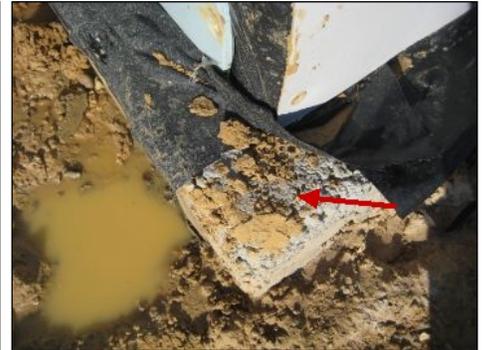
• Several corners of the foundation are not covered with plastic. Plastic should cover brick ledge completely so cracks are not formed in brick veneer wall when foundation settles.

Missing plastic at front elevation

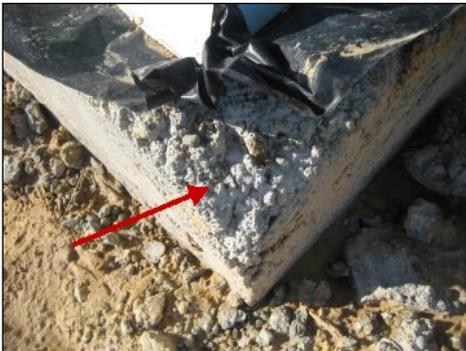
Exposed aggregate at front elevation/no plastic

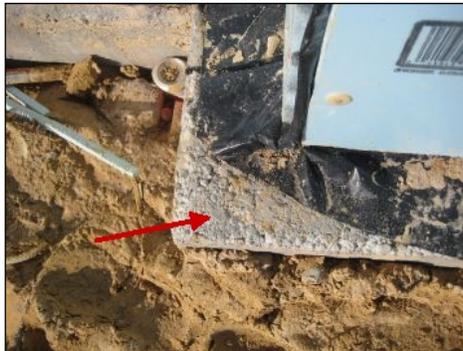
Foundation corners are not covered with plastic

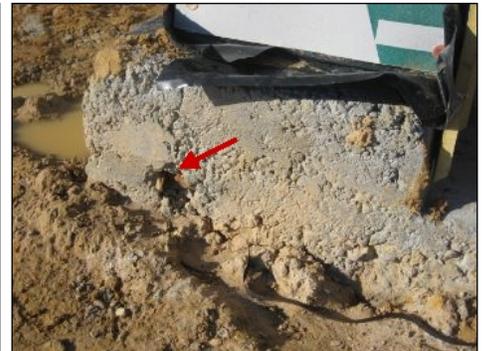
• Exposed post tension cable "dead end" anchor was observed at the front left corner of the foundation. It is recommended to seal/patch this with a non shrinking epoxy grout to prevent corrosion of cables and cable supports.

Dead end anchor exposed at the front left corner/honeycomb

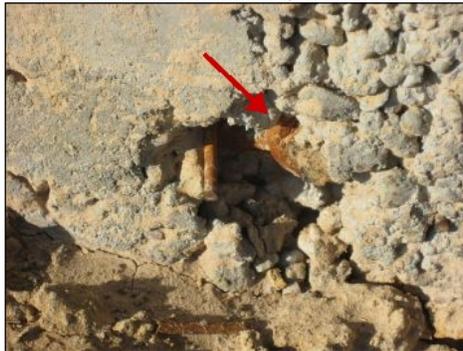
Dead end anchor exposed at the left front corner

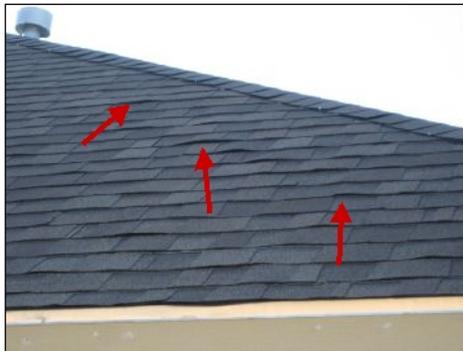
- **The roof covering and all of its components will be fully evaluated during the final inspection.**
- **Observed shingles that are cupping/lifting at the roof covering. Asphalt shingles have an adhesive strip that softens during warm weather. When the shingles heat up, they become flexible and the adhesive bonds the shingles in place. Before new shingles seal down, they can look uneven or "cupping". If shingles are newly installed, it is recommended to monitor the shingles during the summer months to be sure they lay flat.**

Cupped shingles

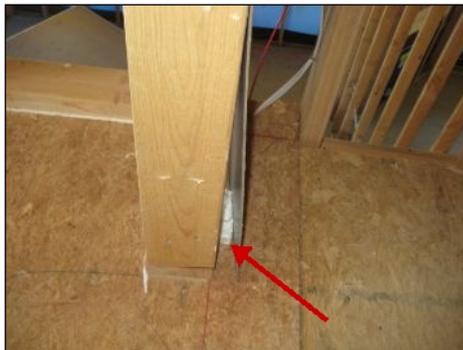
- **Thermal barrier is not secure in attic. Thermal barrier/deny board should be nailed and sealed completely.**
- **Recommend removing exposed nails from lumber in front of mechanical equipment.**

Thermal barrier is not secure in attic

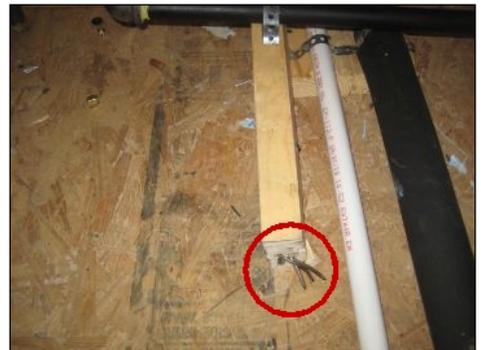
Remove nails at attic landing

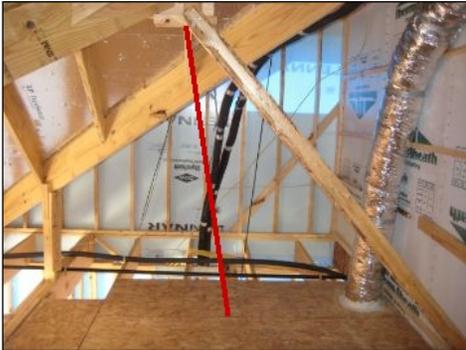
- **Recommend adding a ridge support at front elevation attic. The support in place is angled in a way that it may not be adequately supporting weight above.**

Support ridge in front elevation attic space

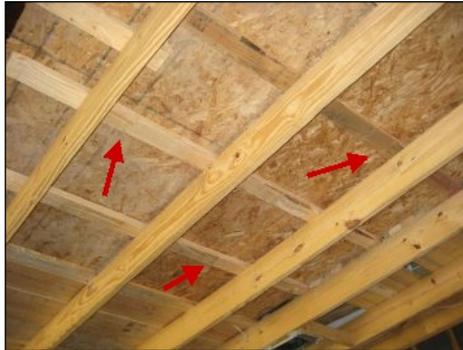
- **Access to mechanical equipment in attic should not be obstructed and attic landing/walkway should be solid 3/4" floor decking material (minimum), continuous, and not less than 24 inches wide. Attic walkway is missing material and is not supported adequately. Finger Jointed material are to be used for vertical support studs and not as support for equipment.**

Finger joints used as support to mechanical equipment

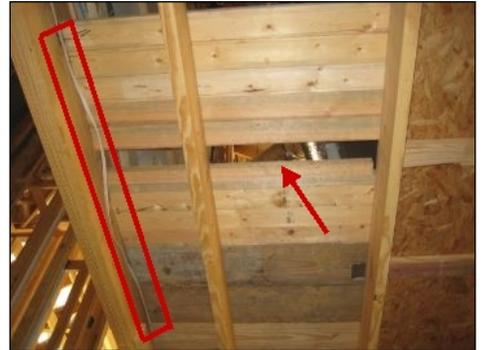
Attic landing not supported/missing lumber

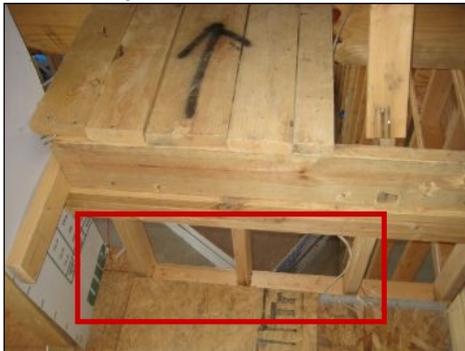
- **Platform created for water heaters should be supported with lateral blocks or double joist to adequately support the weight of two water heaters. There is no platform behind the water heaters. Recommend adding step for access to water heaters.**

Add step to platform to water heaters

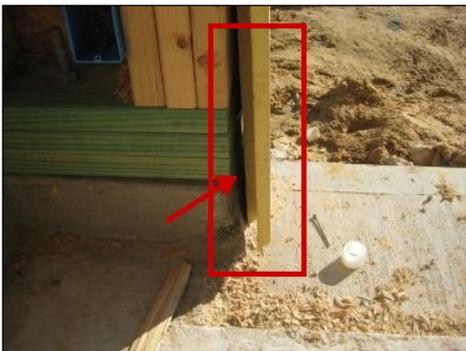
- Right side garage door trim board is bowed at the bottom due to concrete foundation wall.
- Any tear, rip, and/or damaged sheathing should be taped and sealed prior to exterior cladding install. Sheathing joints not taped at the rear elevation of the home. Check all.

Bow at lower garage door trim

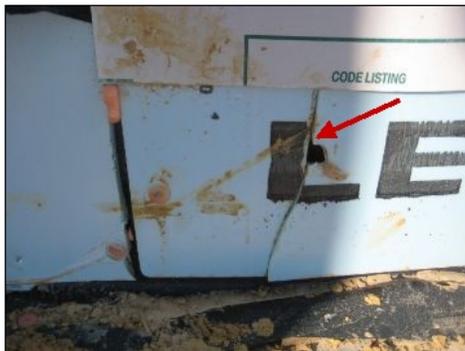
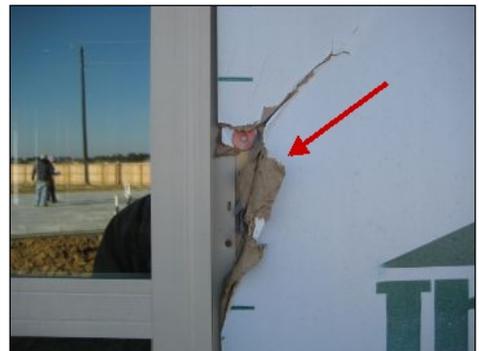
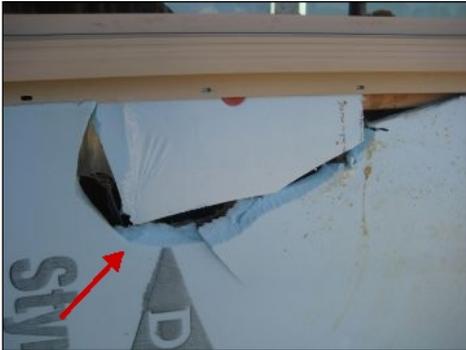
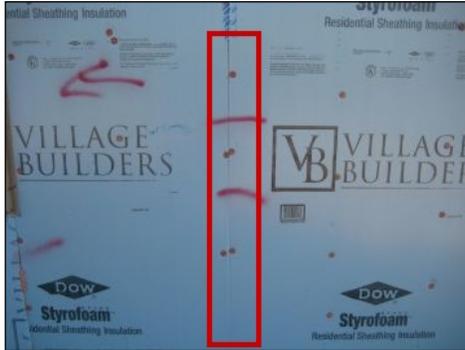
Sheathing should be taped/sealed at front elevation

Sheathing should be taped/sealed at the right elevation

Sheathing should be taped/sealed at left elevation

Sheathing should be taped/sealed at rear elevation

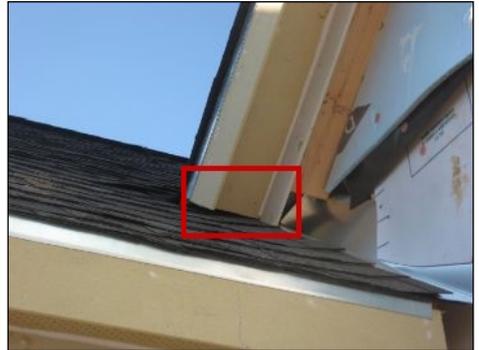
- Recommend adding sole plate anchors to the kitchen sink half wall.
- Missing lap siding at left elevation, second floor.
- The brick fascia, soffit, and brick frieze should not rest directly on the shingles. There should be at minimum a 2" gap so material does not wick moisture. Siding trim material is in contact at the front elevation where eave meets the garage shingles.

No gap between siding trim and shingles

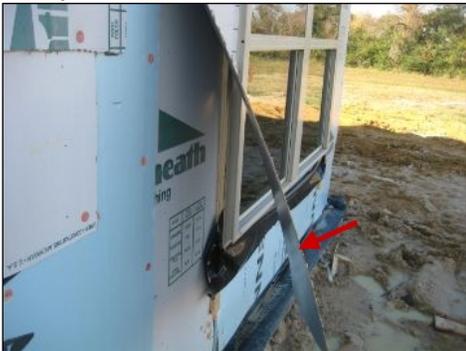
- The exterior sheathing and thermal barrier should be nailed following the manufacture requirements. Check all.
- Metal ties/nail guards are missing at several locations throughout home. These metal ties will help support the lumber that has been altered by notching and/or bored holes. Areas include but are not limited to the garage, front entry hallway, and the utility room. Check all.

Thermal barrier not attached at right elevation of home

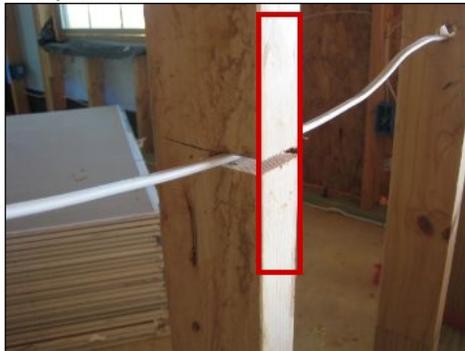
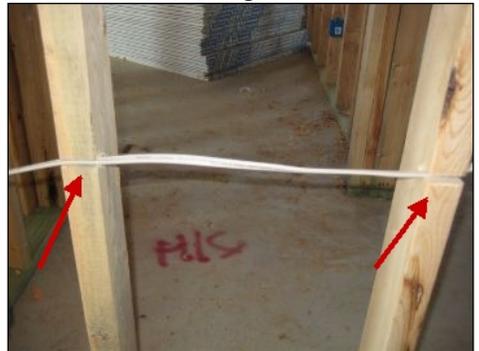
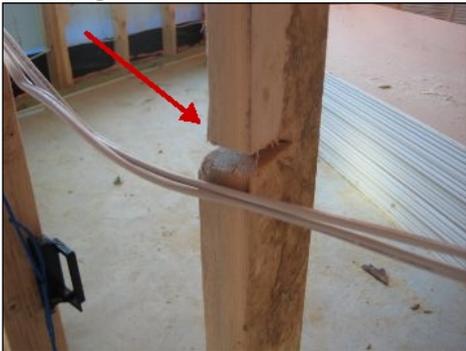
Add metal tie to support notch in stud

Add metal tie to support notched in stud/protect wire

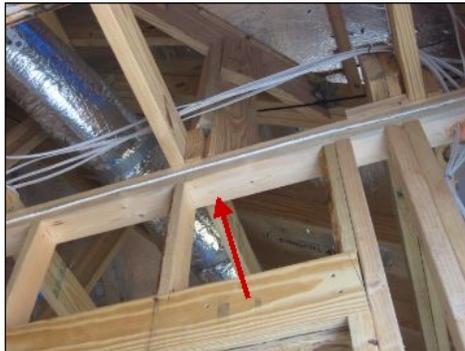
- Missing double studs under ridge and valley supports in the front entry hallway and secondary bedroom hallway.

Add stud to support valley rafter at front entry

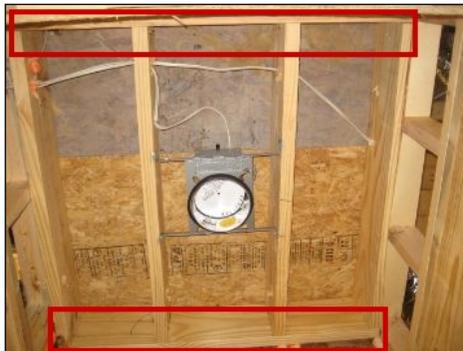
- **Missing joist hangers at master bedroom hallway. The area above is used as a landing/walkway for the mechanical equipment and should be supported.**

Missing joist hangers at master bedroom hallway

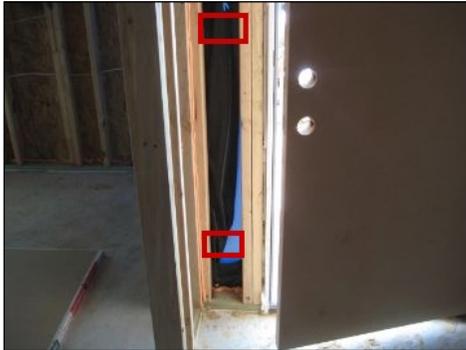
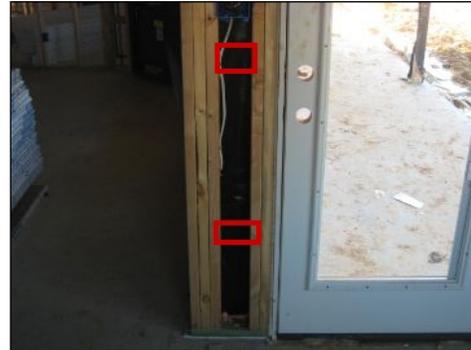
- **Only the exterior passage doors are present at this time of construction, hardware is not present at this time of the inspection. The exterior and interior doors will be inspected and operated during the final inspection.**
- **Recommend blocking left and right side of front and back doors to limit drywall cracks in the future.**

Add blocks to support door frame

Add block to back door to support frame

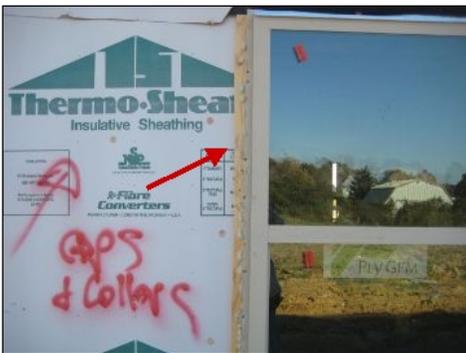
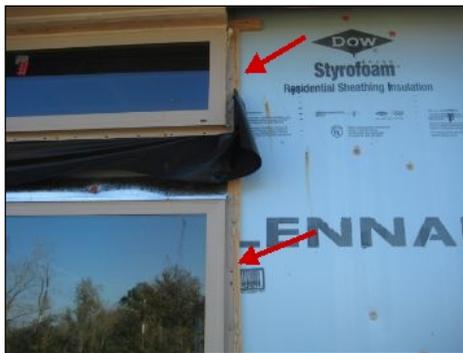
- **Windows at the rear elevation are missing jamb flashing.**
- **Two rear elevation windows are not properly secured. These windows are missing poly-seal on the interior and jamb flashing at the exterior.**

Missing window jamb flashing at rear elevation

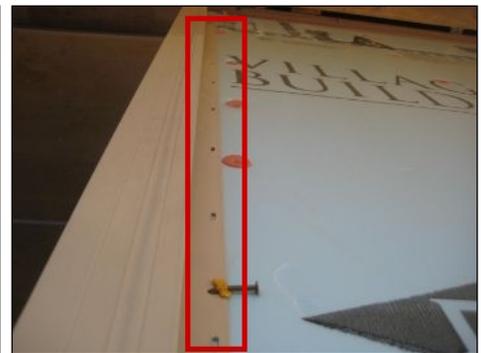
Windows not secure at rear elevation

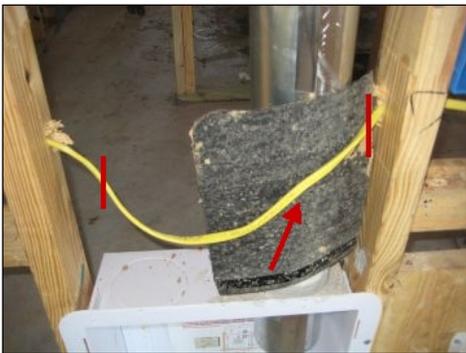
- **Outlets, switches, and fixtures will be fully inspected during the final home inspection.**
- **Recommend removing shingle and properly protecting branch wire from the heat of the dryer vent pipe in the utility room.**
- **Missing protective nail plates at several locations throughout home. These metal plates protect wires from being damaged with drywall and/or cabinet nails. Some areas include but are not limited to the garage, left elevation secondary bedroom, master bathroom and kitchen. Check all.**

Protect wire from dryer exhaust pipe/remove shingle

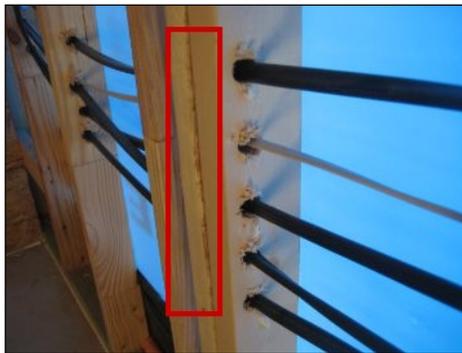
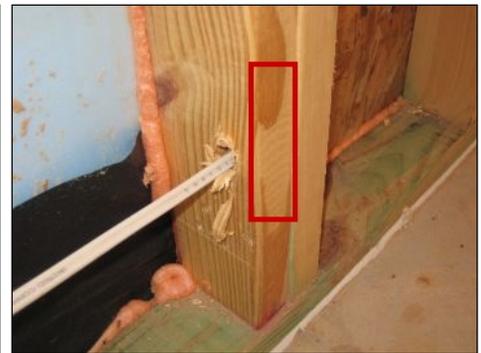
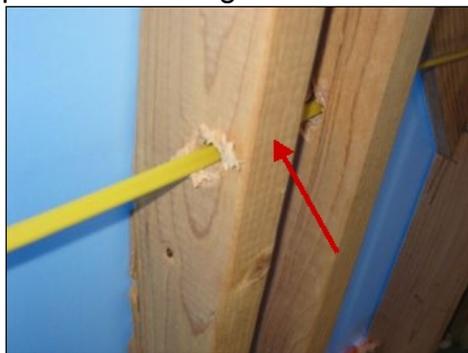
Add metal nail plate at left elevation secondary bedroom

Add metal nail plate at front room

Add metal nail plate at kitchen wall

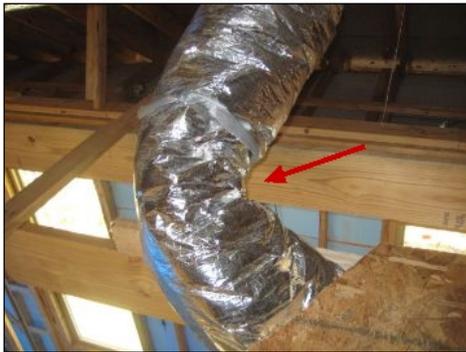
- Visually inspected the accessible areas of the HVAC ductwork only.
- HVAC duct in front of water heater and above the master bedroom is kinked.
- Fresh air ductwork is not connected at the time of the inspection.

HVAC ductwork is kinked in rear attic space

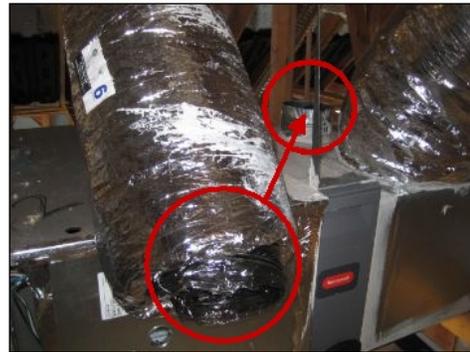
Fresh air intake is not connected

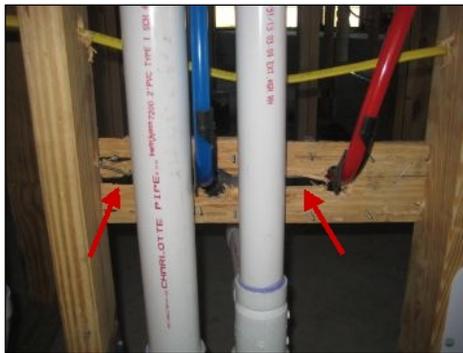
- **Type = PEX Piping**
- **Static Water Pressure Reading: will be evaluated at the final home inspection**
- **Lumber supporting vanity hot and cold PEX lines is inadequate at the hallway bathroom.**
- **Cold water PEX line not protected at the exterior rear right elevation of the home.**
- **Cold water line in hallway bathroom is not protected with metal plate.**

Recommend replacing damaged lumber

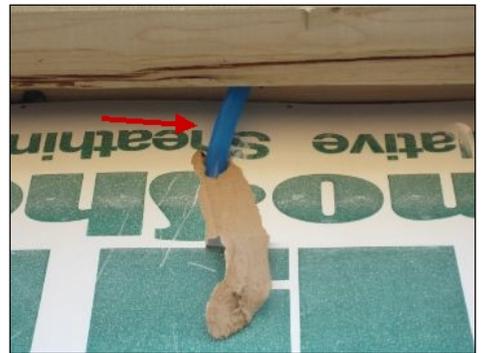
Exposed water line at rear elevation of home

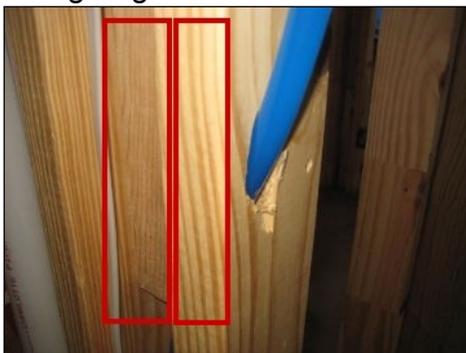
Water line not protected at hallway bathroom

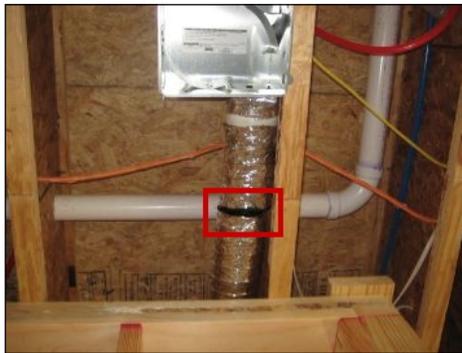
- **Inspected the vent ducts only at the time of the inspection.**
- **Vent duct in utility has a gap that needs to be sealed.**

Exhaust duct pipe is not sealed above utility room
