# Southern Star Inspections, LLC

## Property Inspection Report

1234 Texas St, Houston, TX 77040

Date of Inspection: 4/27/2020 Time: 8:30 AM

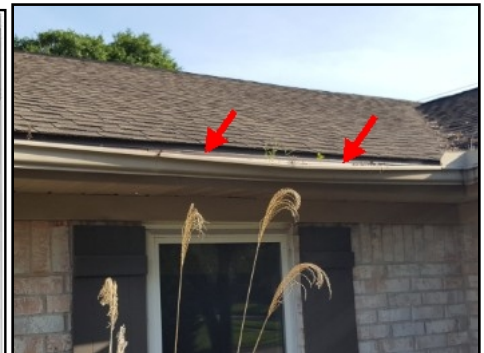
Gutter not secure at front left elevation

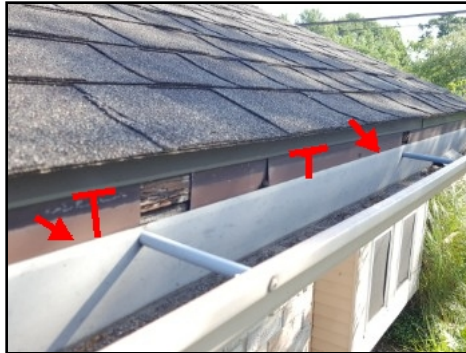
Gutters not installed behind drip edge

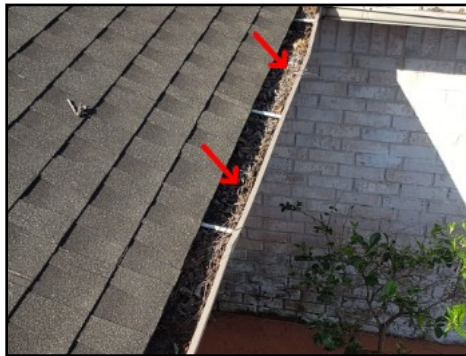
Debris in gutters

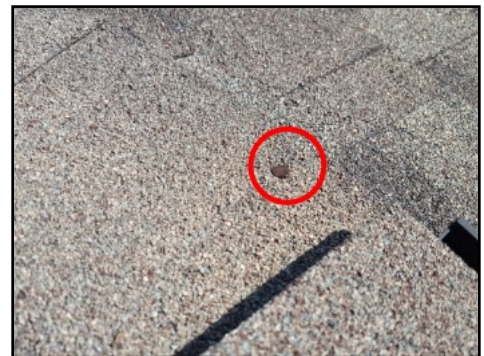
Exposed nails at roof covering

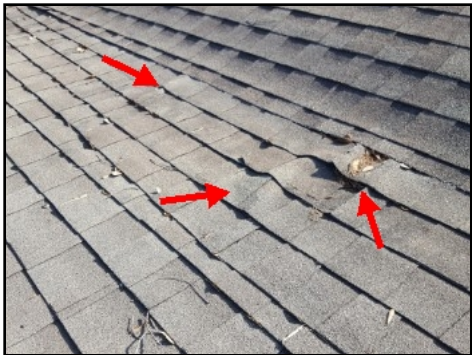
Shingles cupped/buckled at rear elevation

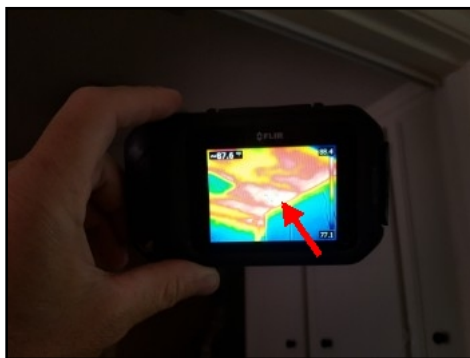
Evidence of heat transfer at utility room

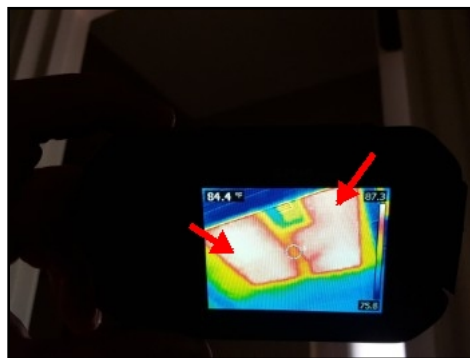
Evidence of heat transfer at powder bathroom

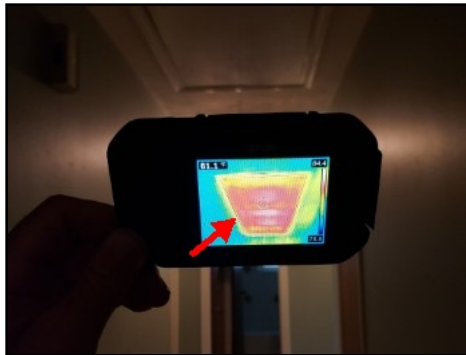
Evidence of heat transfer at attic staircase

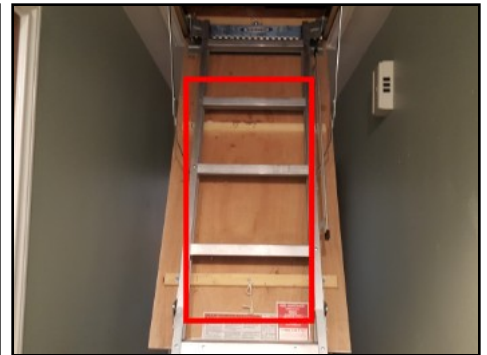
Attic staircase not insulated

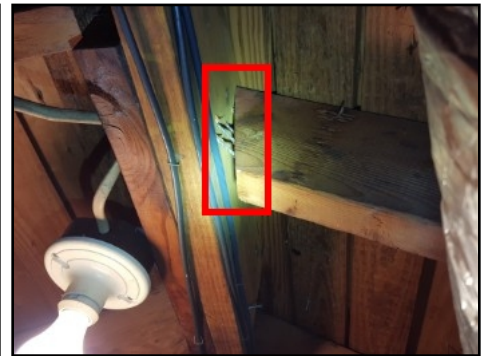
Rafter separation at ridge board

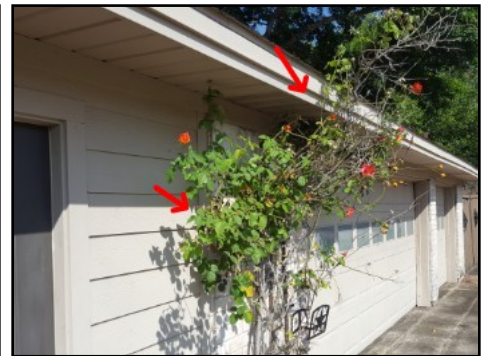
Vegetation in contact with structure

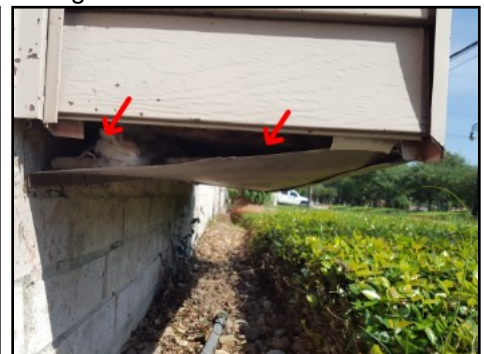
Siding not secure at right elevation

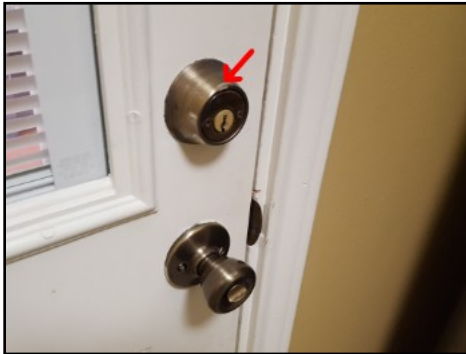
Double dead bolt present

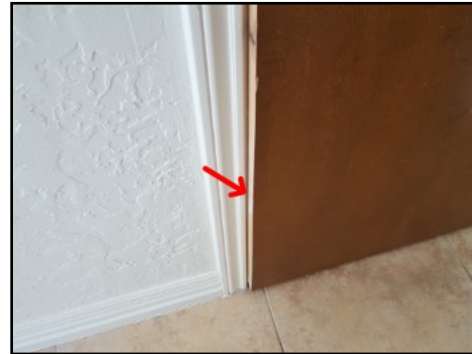
Door rubs on frame/jamb

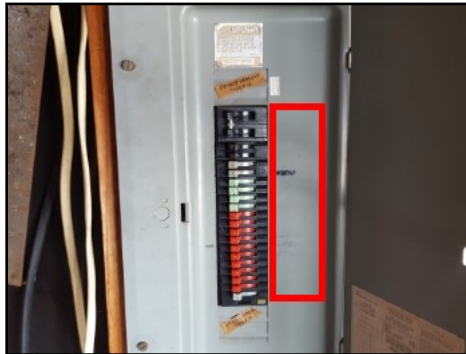
Breaker panel not labeled

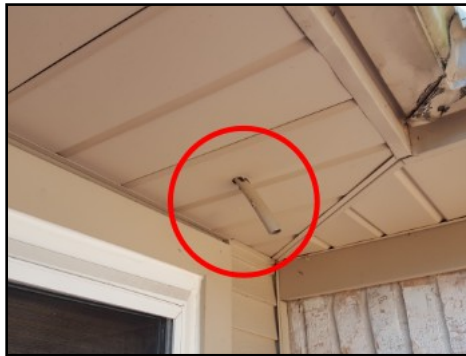
Secondary A/C drain line at rear elevation

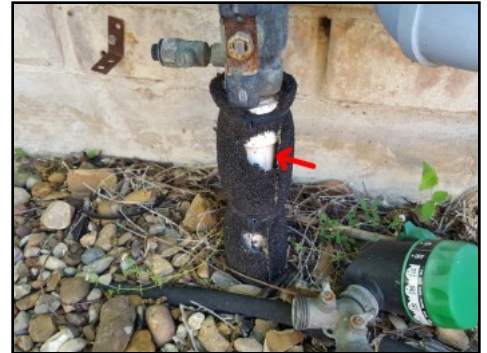
- **There were no leaks observed at the accessible plumbing fixtures/piping at the time of the inspection.**
- **Exterior plumbing supply pipes are not insulated at various locations of the home/detached garage at the time of the inspection. Recommend insulating all exterior (including detached garage) plumbing pipes and hose bib pipes to protect from hard freeze. Check all.**

Insulate exposed plumbing pipes

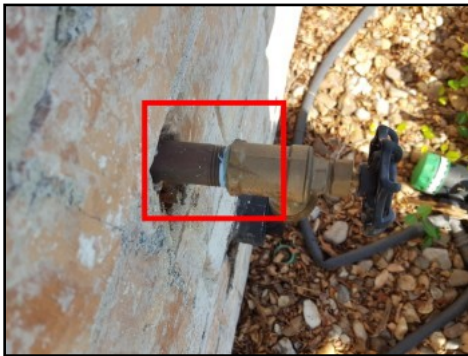
Insulate exposed plumbing pipes

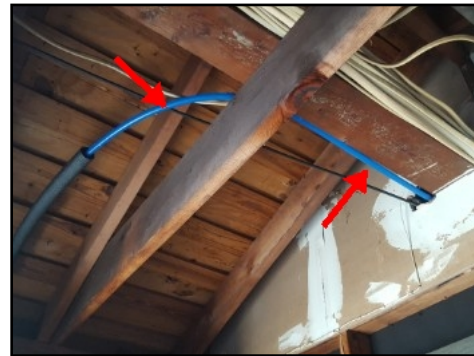
Supply line not insulated within garage

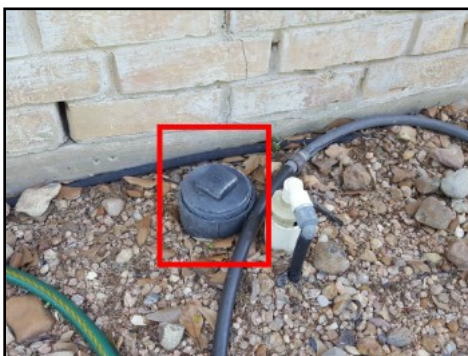
Main sewer clean out

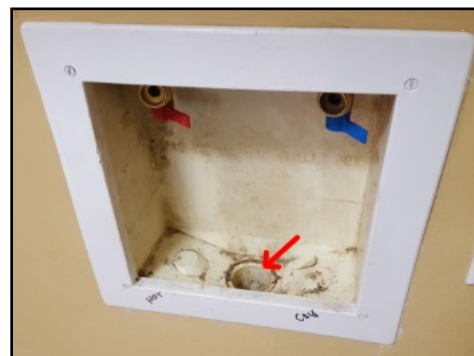
Drain line uncovered in utility room

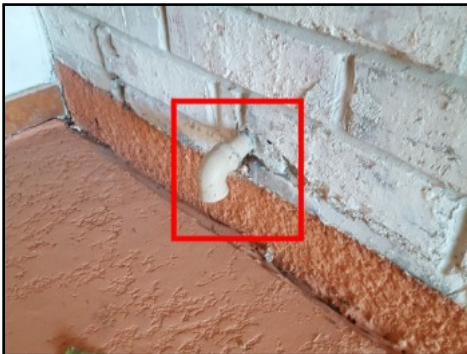
Drain line termination at breezeway

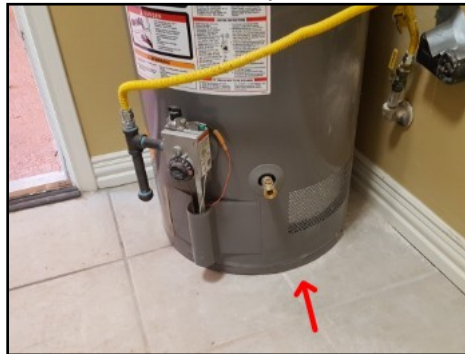
- **Water Heater - Rheem**
- **model# = PROG50-38N RH60**
- **serial# = Q201731222**
- **manufacture year = 2017**
- **The Temperature and Pressure Relief Valve(s) on the water heater(s) do not appear to be rusted or damaged at the time of the inspection. The TPR Valves are not tested at the time of the inspection due to the possibility of the valve not resetting in place. Recommend testing the valve once a year by owner or by a licensed plumber.**
- **Recommend following the manufacture care and maintenance instructions.**
- **Drain pan beneath the water heater with drain line terminated to the exterior is not present at the time of the inspection. When a leak at the water heater can damage the home, it is required to have drain pan with drain line installed.**

Drain pan with drain line not present

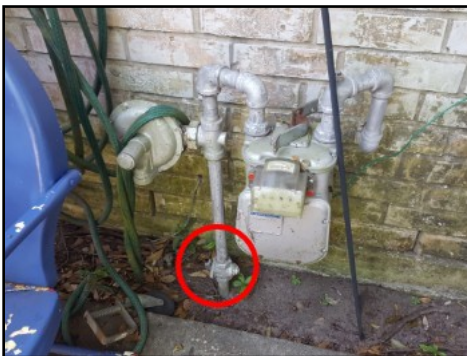
Gas meter and main shut off valve

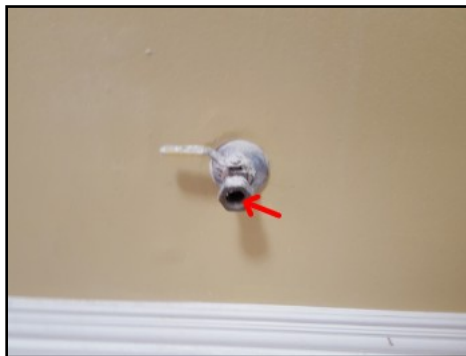
- **\*Visual inspection of the Gas supply components only.**
- **Main gas meter and shut off valve is located on the rear elevation of the home.**
- **Gas service line is not in use and not capped in the utility room at the time of the inspection I. All gas lines not in use should be capped and service vale placed in the off position. Check all.**
- **Sediment trap is not present at the Furnace gas line at the time of the inspection.**
- **Flex gas line connector is unprotected through the furnace cabinet/enclosure at the time of the inspection. Connectors shall not be concealed within, or extended through, walls, floors, partitions, ceilings or appliance housings. Gas line should be hard piped at this area.**

Gas line not capped off in utility room

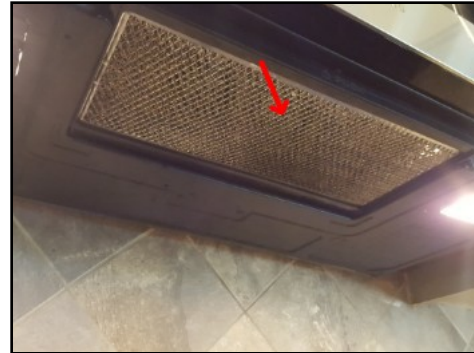
Filter dirty

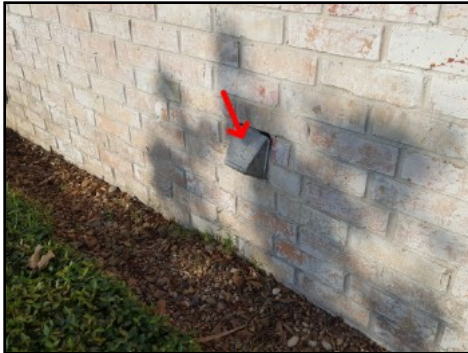
Dryer vent termination

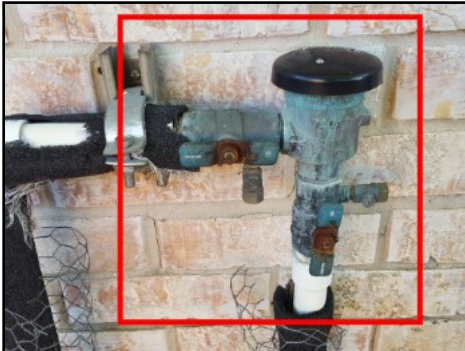
Main irrigation valves/anti-siphon device

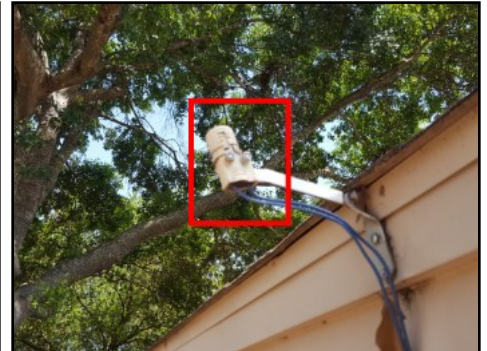
Rain sensor not tested

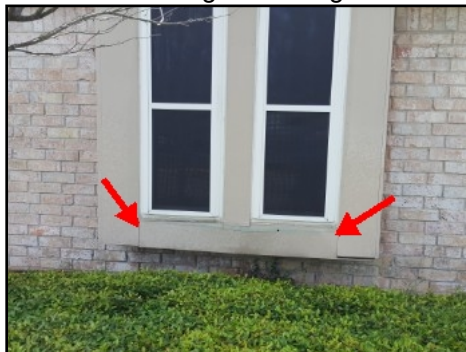
- **Coverage of sprinkler heads next to structure, driveway, sidewalks, and fencing should be adjusted so they do not spray directly on these areas.**

Sprinkler spraying structure

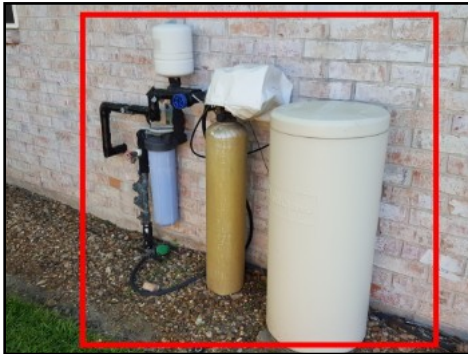
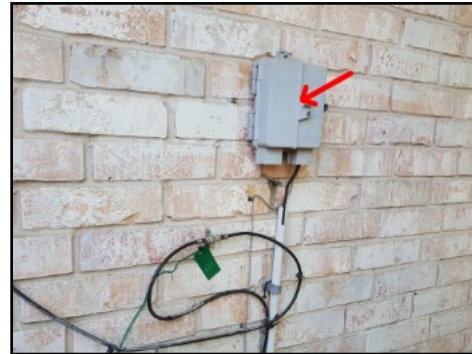
- Water softener/filtration system is not within the scope of the inspection. Recommend consulting with the seller regarding the proper operation and maintenance schedule.
- Low voltage wiring and/or stereo equipment located at various locations of the home and attic space are not within the scope of this inspection. Recommend consulting with the seller regarding proper operation and maintenance schedule.

Not within scope of inspection
