## Property Inspection Report

1234 Texas Cir., Tomball, TX 77377

Date of Inspection: 1/2/2020 Time: 8:00 AM

Inspector: Travis Kepp

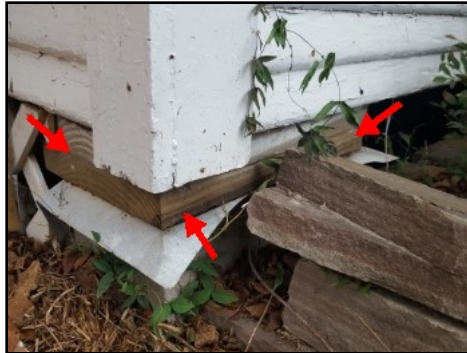
Exposed lumber at front left corner

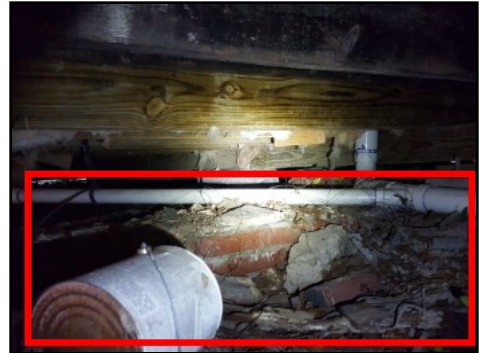
Debris/voids present within crawlspace

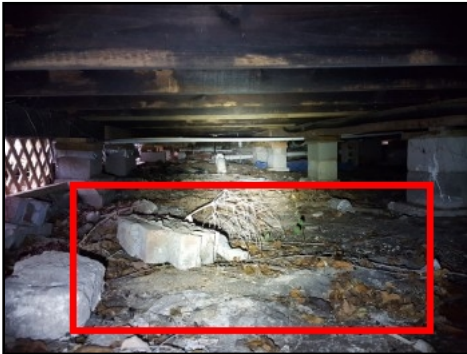
Debris/voids present within crawlspace

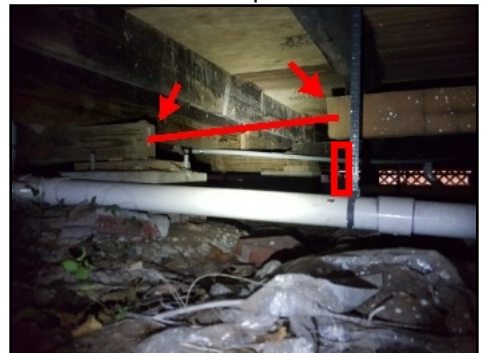
Floor joist altered/not supported

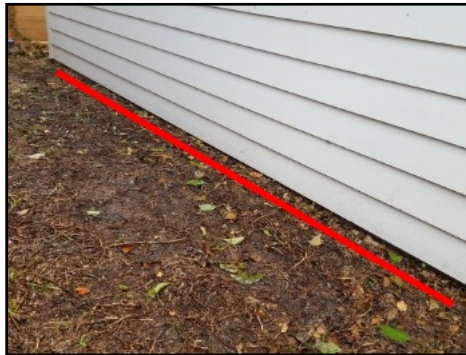
High grading at detached garage

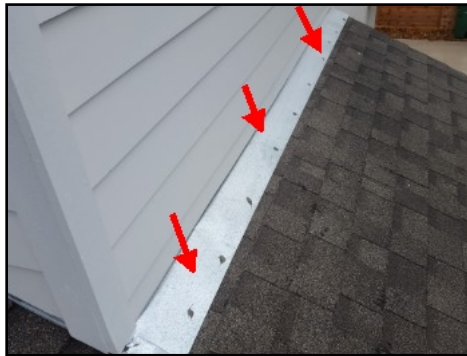
Flashing not painted

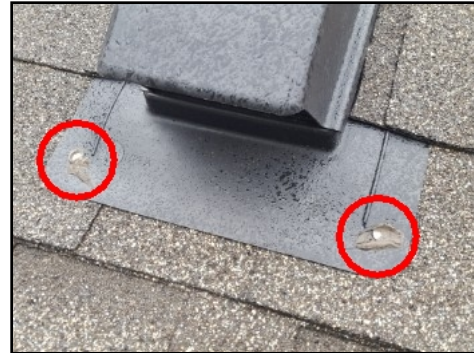
Exposed nails at roof covering

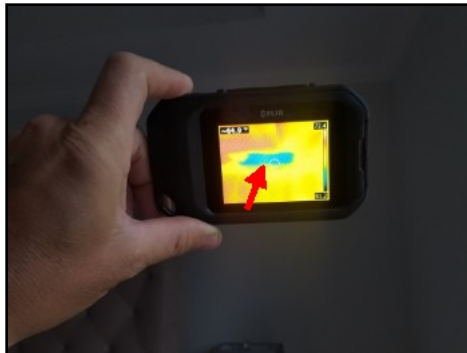
Evidence of poor insulation at master bedroom

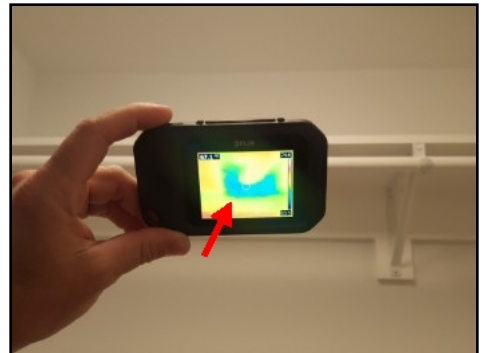
Evidence of poor insulation at master closet

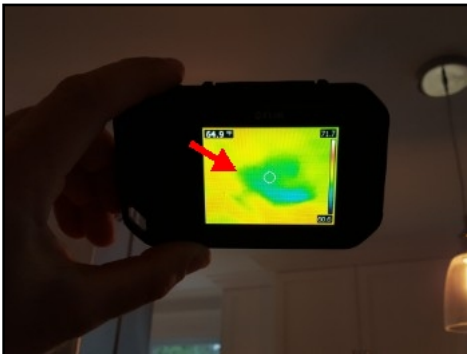
Evidence of poor insulation at kitchen

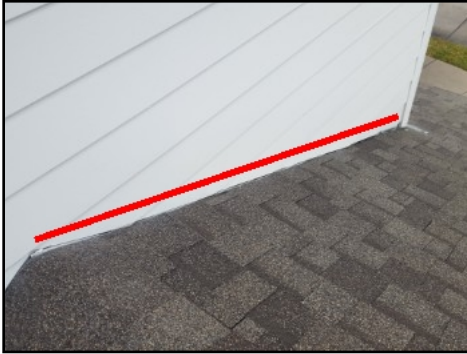
Siding in contact with shingles

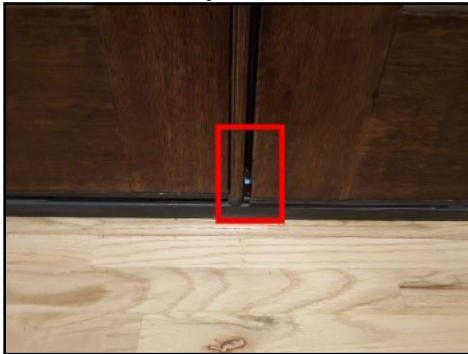
Gap at lower strike side

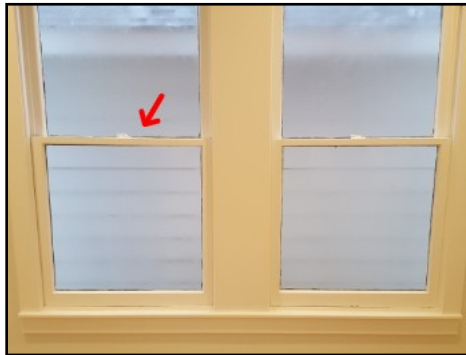
Window stuck in place

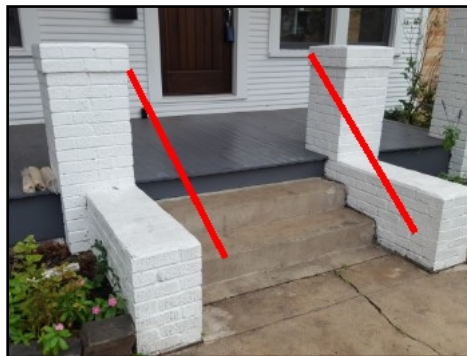
Handrail not present

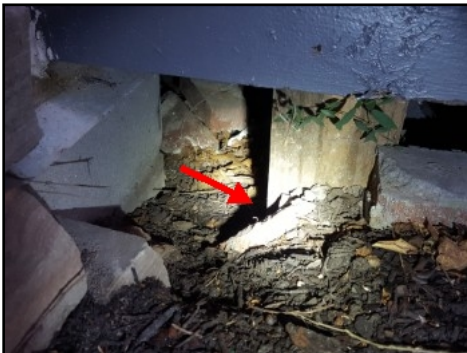
Post material in contact with grade

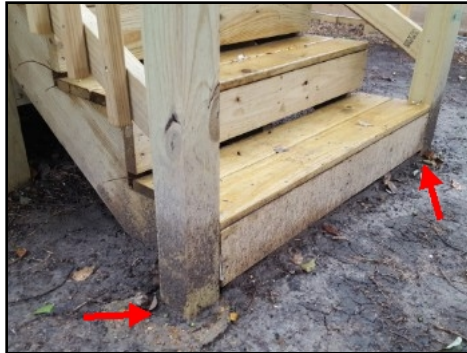
Post material in contact with grade/soil

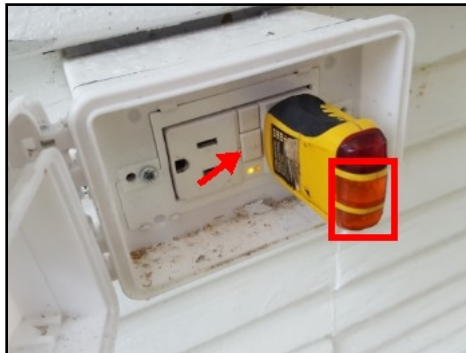
GFCI inoperable/Not resetting

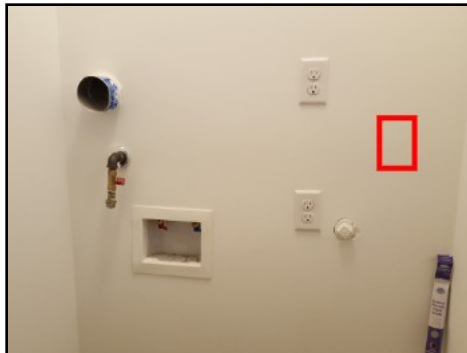
220 receptacle not present

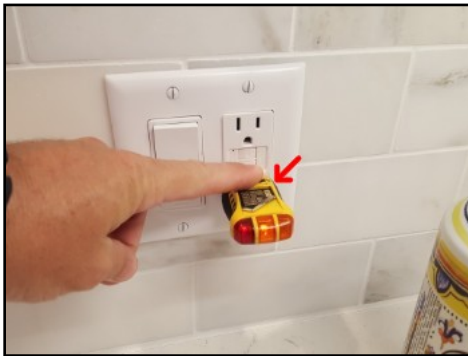
• **The GFCI (ground fault circuit interrupter) receptacle to the right side of the kitchen sink is not properly functioning/tripping at the time of the inspection. Ground Fault Circuit Interrupter (GFCI) receptacles are required in all wet areas. Required areas include: exterior, garage, kitchen backsplash, and bathrooms. Check all.**

GFCI receptacle not tripping

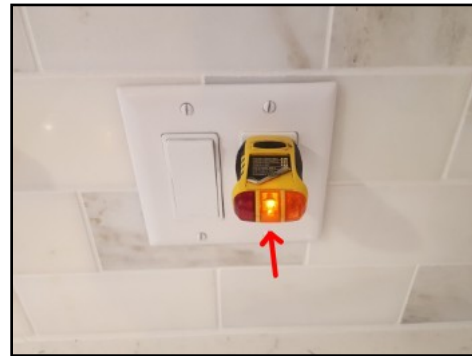
• **GFCI receptacle at the right elevation of kitchen sink indicates "open ground" at the time of the inspection. Check all.**

"Open ground" at GFCI receptacle

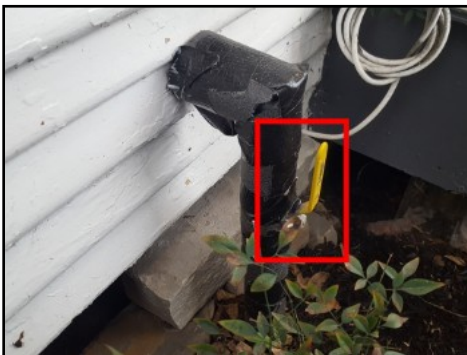
Main water shut off valve

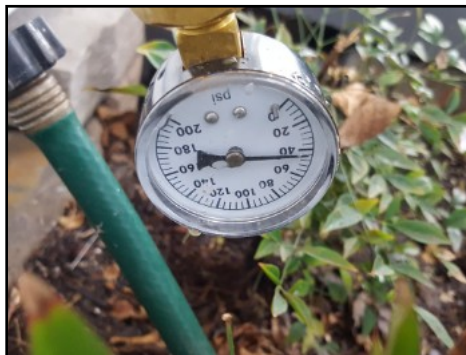
- Type = PEX Piping
- Static Water Pressure Reading: Approx. 45 psi
- Water line to fridge is not tested during inspection for proper pressure. Recommend flushing of line upon move in. Leaks were not observed in visible areas at the time of the inspection.

Water pressure at front elevation

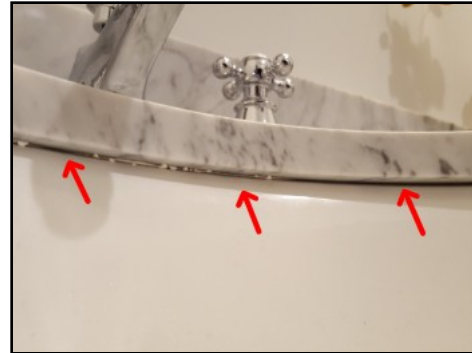
- Sealant is not present at the bathroom vanity intersections with counter tops at the time of the inspection. Check all.

Bathroom vanities not sealed at counter top

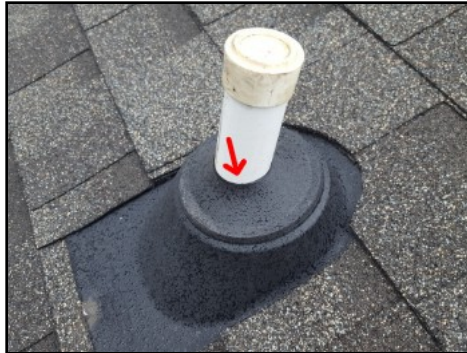
Stack vent/roof jack not sealed

- Stack vent is capped/covered at the time of the inspection. Cap should be removed so vent can allow sewer gas to escape as intended. Recommend sealing vent at intersection with roof jack to deter moisture penetration. Check all.

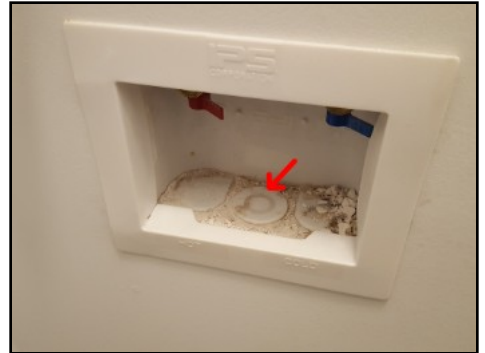
Remove cap/cover at utility room

Builder/plumber should properly remove cap/cover prior to closing on the home. Washing machine drain is not tested for flow and/or drainage. Recommend monitoring first drain cycle of washing machine.

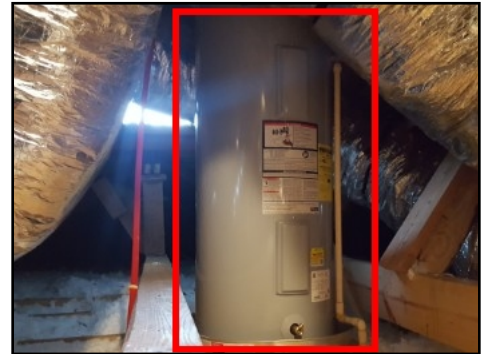
Water heater located within the lower attic space

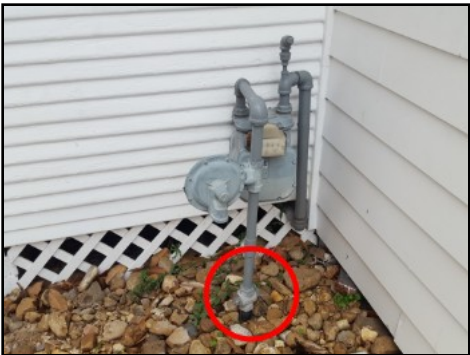
Gas meter and main shut off valve

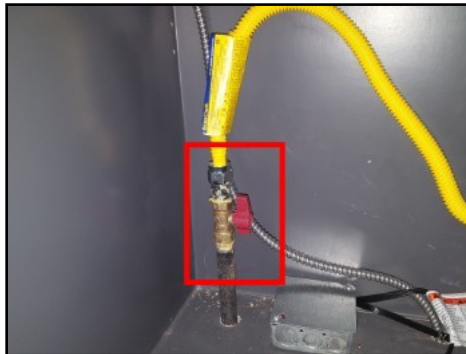
Gas line service valve is beneath unit

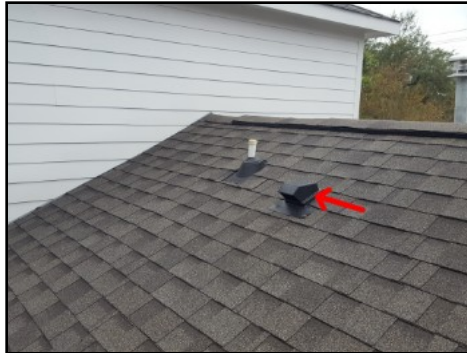
Dryer vent termination
