# Southern Star Inspections, LLC

## Property Inspection Report

1234 Texas Dr., Pinehurst, TX 77362

Date of Inspection: 2/3/2020 Time: 8:30 AM

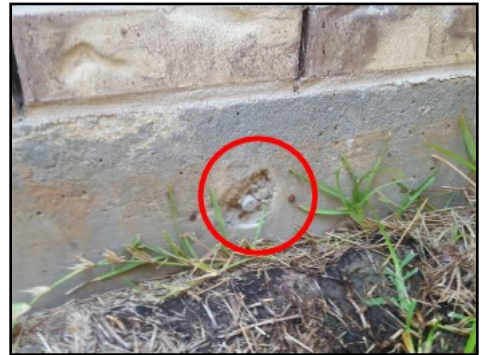
Exposed tension cable at rear left elevation

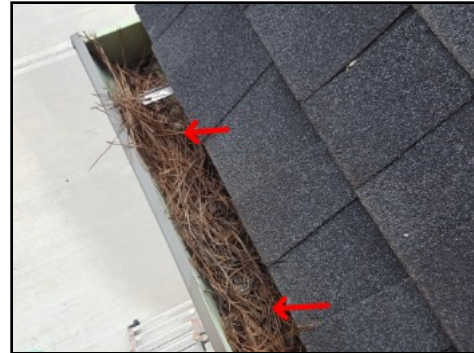
Debris in gutters

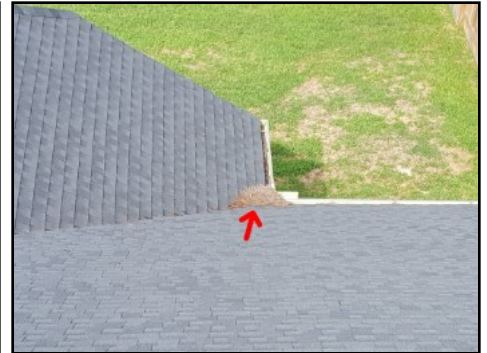
Debris on roof covering

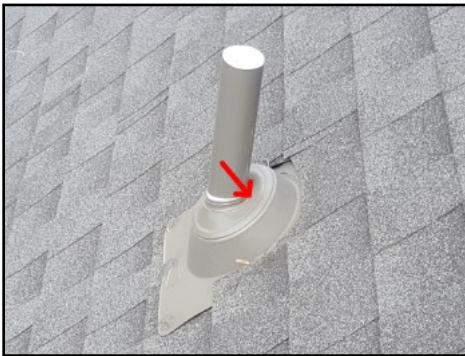
Buckled roof jack at upper rear left elevation

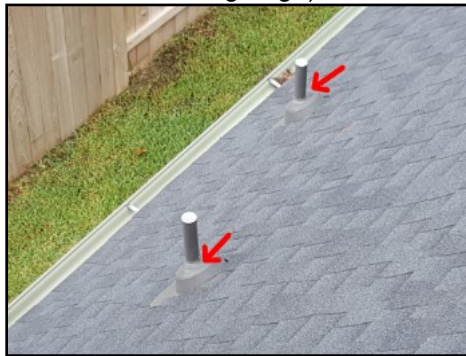
Buckled roof jacks at rear left elevation

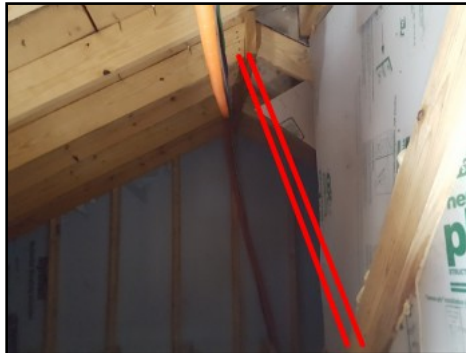
Ridge brace not present over 5' garage extension

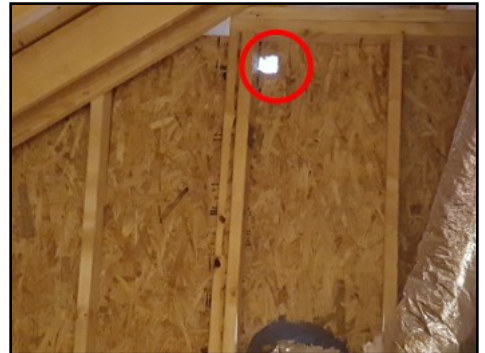
Seal hole at lower rear right attic space

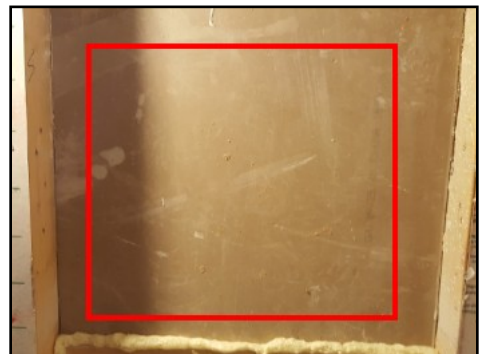
Insulation not present over scuttle door

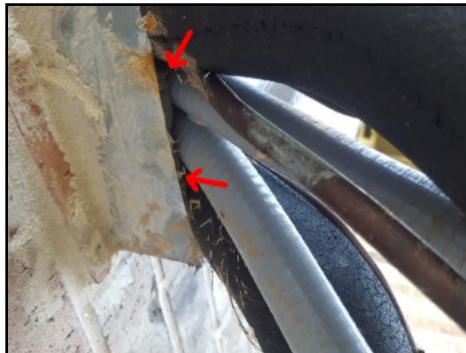
A/C refrigerant lines not sealed

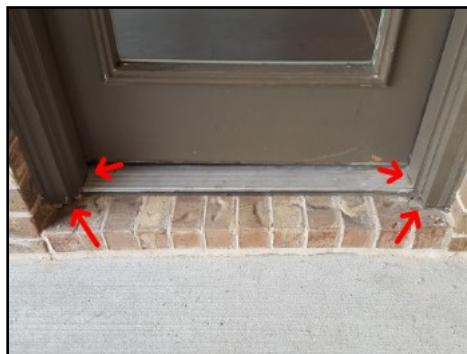
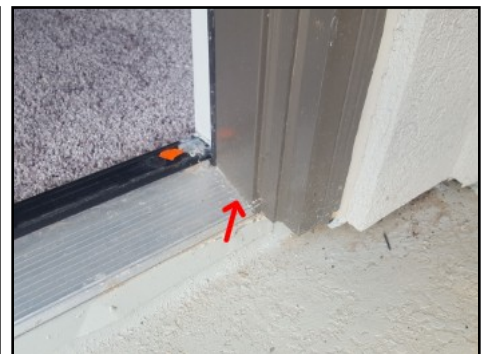
Seal door thresholds/jambs

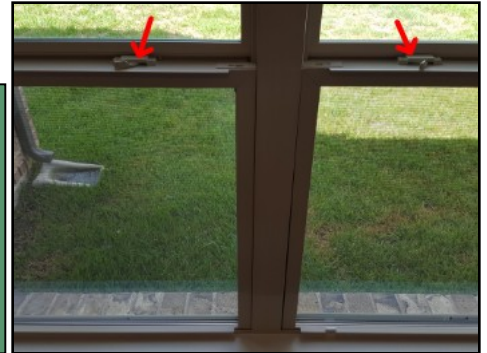
Windows not latching

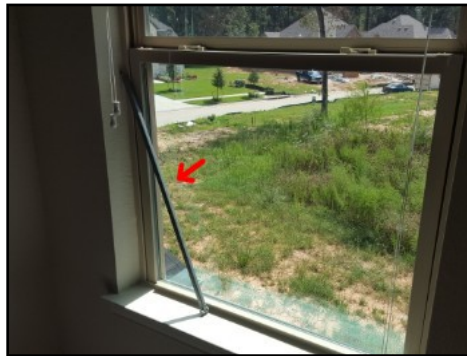
Sash track not secure in place

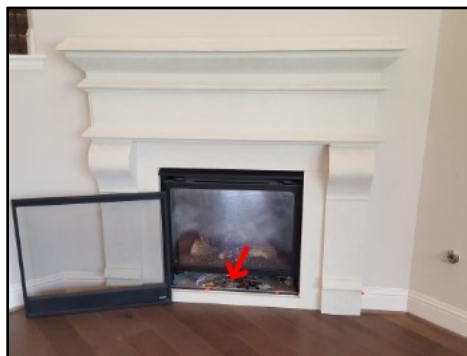
- **Fireplace has a glass front and is operated by a remote control. Remote control was NOT present at the time of the inspection. Inspector tested fireplace using manual mode. Recommend consulting with the builder regarding the location of the remote and proper operation of the fireplace prior to closing on the home.**

Tested fireplace using manual mode

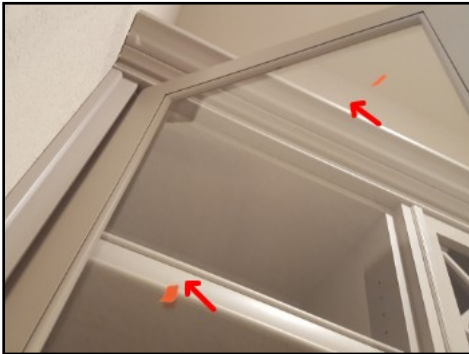
Butlers pantry cabinet glass scratched

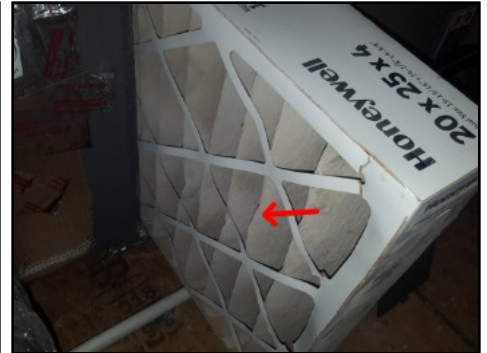
HVAC media filter dirty

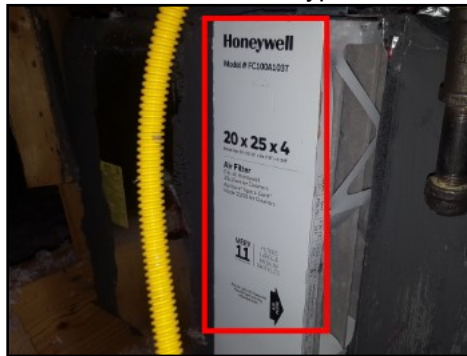
HVAC media filter type/size

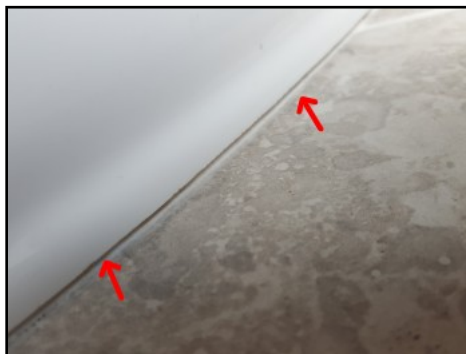
- **Type = PEX Piping**
- **Static Water Pressure Reading: Approx. 50 psi**
- **Water line to fridge is not tested during inspection for proper pressure. Recommend flushing of line upon move in. Leaks were not observed in visible areas at the time of the inspection.**
- **Operating the Hot and Cold water valves for the washing machine is not within the scope of the inspection. Leaks were not observed in the visible areas at the time of the inspection.**
- **Faucet at the kitchen sink is missing a "swing" stop, allowing faucet to rotate over the counter top. Recommend checking manufacture install requirements.**
- **There were no leaks observed at the accessible plumbing fixtures/piping at the time of the inspection.**
- **Tub deck is not properly sealed at the back side near window at the time of the inspection.**

Master bathroom tub deck not sealed

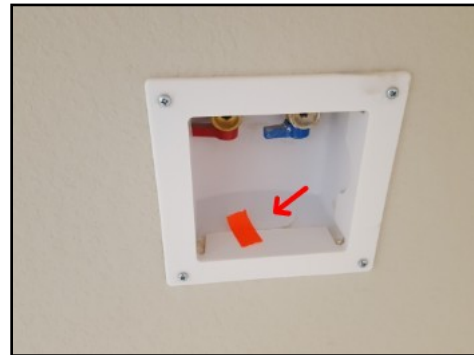
- Drain for washing machine is capped/covered at the time of the inspection. Recommend having builder/plumber remove cover prior to closing on the home. Washing machine drain is not tested for flow and/or drainage. Recommend monitoring first drain cycle of washing machine.

Remove cap/cover

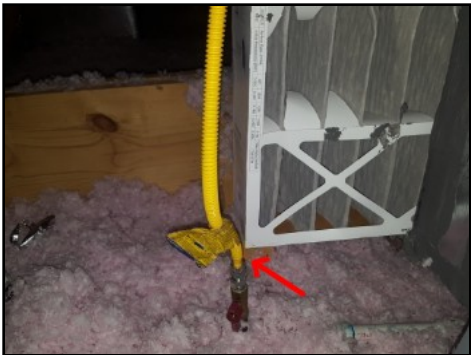
- **\*Visual inspection of the Gas supply components only.**
- **Main gas meter and shut off valve is located on the left elevation of the home.**
- **Upper attic furnace gas line connector is blocking access to safely removing/replacing the HVAC media filter at the time of the inspection. Recommend evaluation/repair by a licensed Plumber prior to closing on the home.**

Gas line blocking HVAC media filter

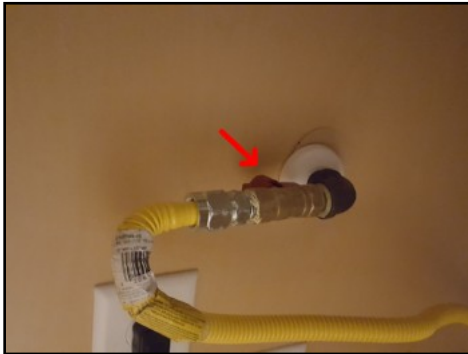
Gas line service valve is beneath unit

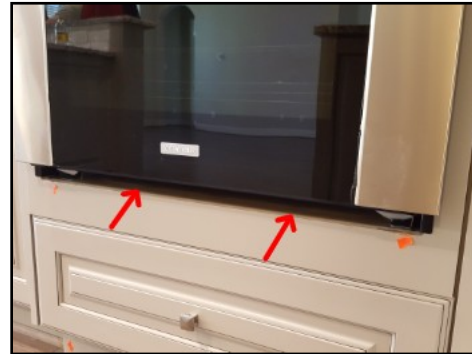
Lower trim cover not present

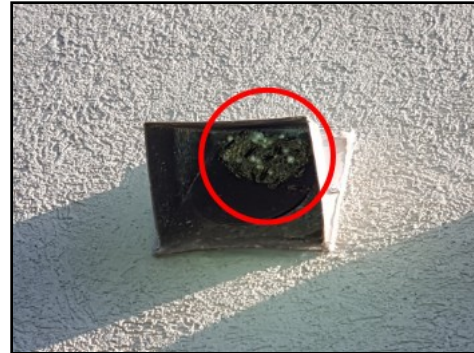
Damper blocked/Hornets nest present

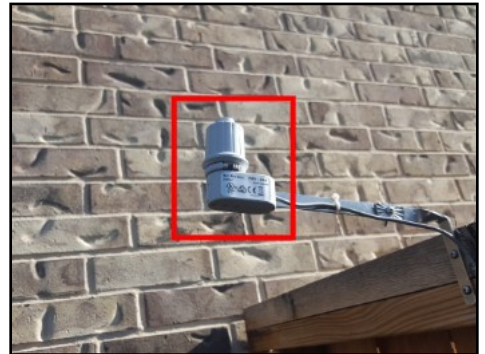
Rain sensor not tested

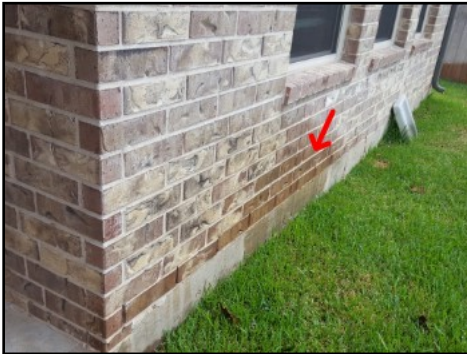
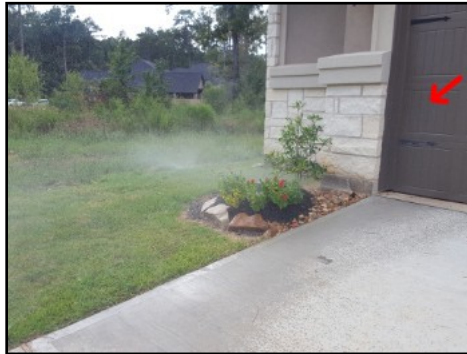
- **Coverage of sprinkler heads next to structure, driveway, sidewalks, and fencing should be adjusted so they do not spray directly on these areas.**

Sprinkler spraying structure

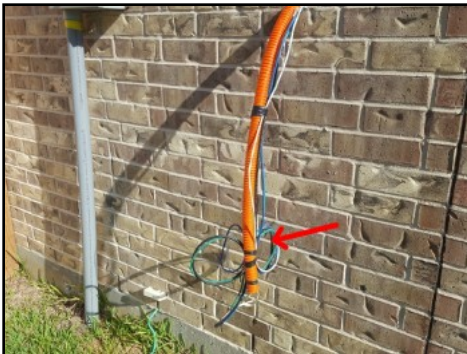
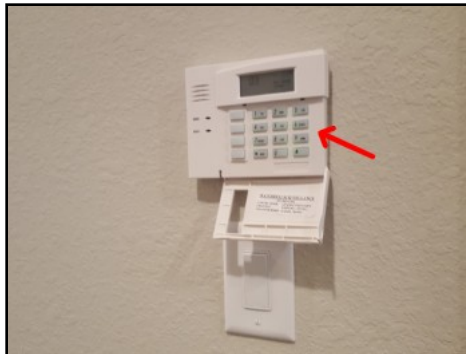
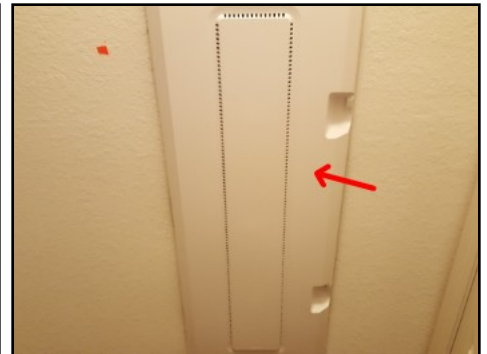
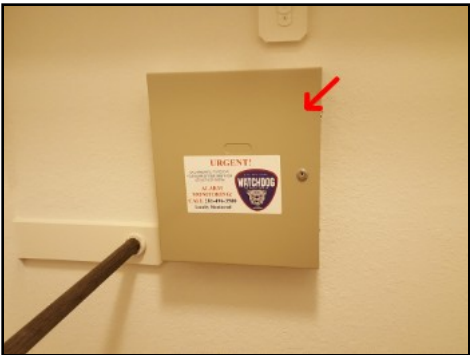
- Low voltage wiring and/or stereo equipment located at various locations of the home and attic space are not within the scope of this inspection. Recommend consulting with the builder regarding proper operation and maintenance schedule.
- Alarm and/or security system is not within the scope of this inspection. Recommend consulting with the builder regarding proper operation and maintenance schedule.

Not within scope of inspection
